CIRCUITS ASSEMBLY

AUGUST 2007

Pb-free PTH Rework on a Thick, Heavy Assembly

A forced convection platform with a solder fountain showed a dramatic impact on copper dissolution.

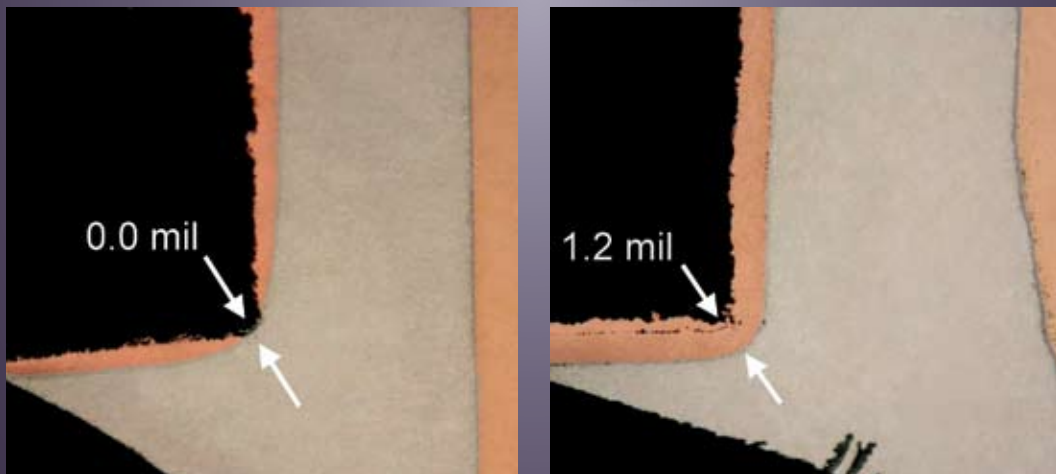
Connector after conventional SAC 305 rework showing copper dissolution (left), and minimal copper dissolution (right) using new SAC 305 rework method.

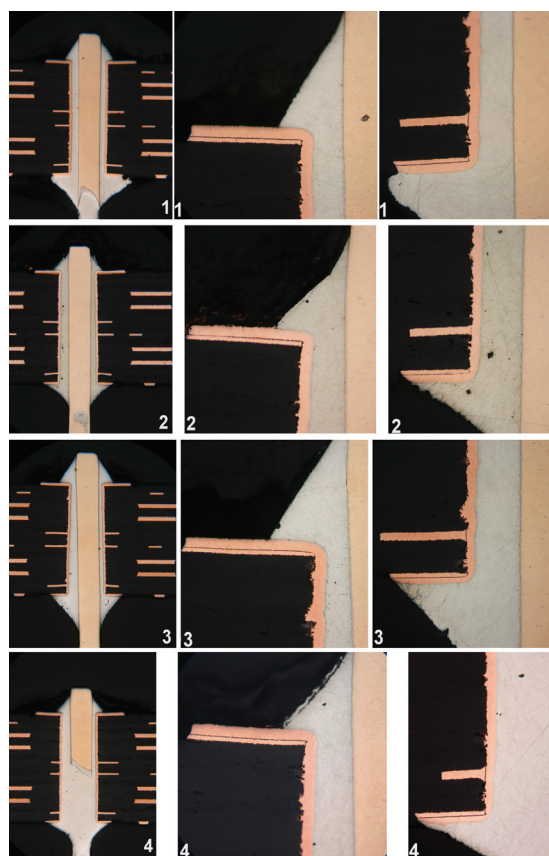
Figure 3. Topside section and process summary for sites 1, 2, 3 and 4 on practice board 1.

Figure 3 shows a summary of the results. The digit in the lower corner of each cross-section corresponds to the applicable site, and each site includes three cross-sections: the complete, top and bottom view. The process summary appears in the right column.

- All four sites were acceptable. There was no evidence of excessively thin or fractured knees, nor was there any significant via wall thinning near the surface. Copper thickness was above the IPC Class 3 minimum of 0.001".
- Copper dissolution increased for the double rework as compared

with the single rework, which was expected, but the increase was smaller than anticipated.

- The difference in copper dissolution between the stagnant and full flow was not significant.
- By the end of the double rework process, the bottomside pads lost approximately one-quarter their original copper thickness, regardless of the method used.

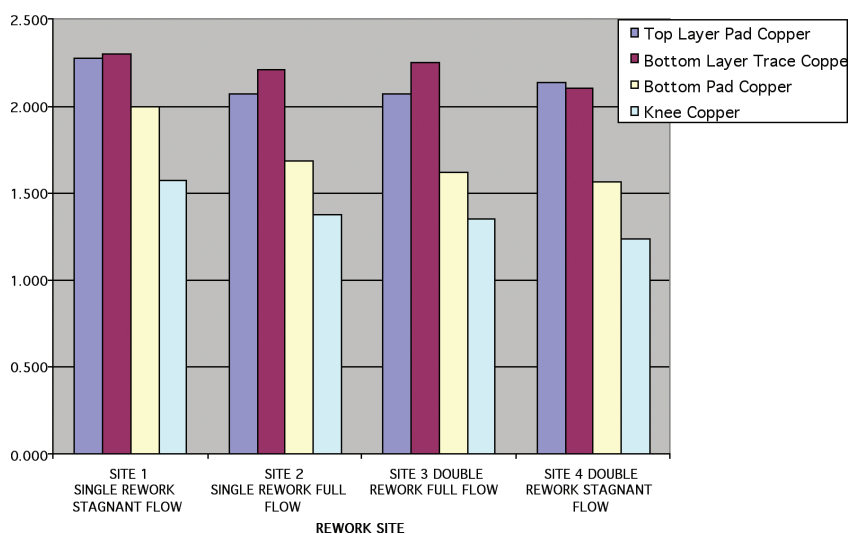
Figure 4. Copper thickness measurements for sites 1-4 on practice board 1 (OSP).

Site 1 Single Rework Stagnant Flow	Site 2 Single Rework Full Flow	Site 3 Double Rework Full Flow	Site 4 Double Rework Stagnant Flow
Top layer pad copper	2.279	2.071	2.071	2.138
Bottom layer trace copper	2.306	2.216	2.257	2.104
Bottom pad copper	1.996	1.688	1.620	1.564
Knee copper	1.575	1.379	1.350	1.238

PCB copper thickness measurements on Sites 1 through 4 were taken (**Figure 4** and **Table 1**). The top layer pad copper is on the board's topside, and masking covers the bottom layer trace copper. Both locations have negligible risk of copper dissolution and can be considered baselines for the original copper thickness. All measurements in **Figure 4** are mils.

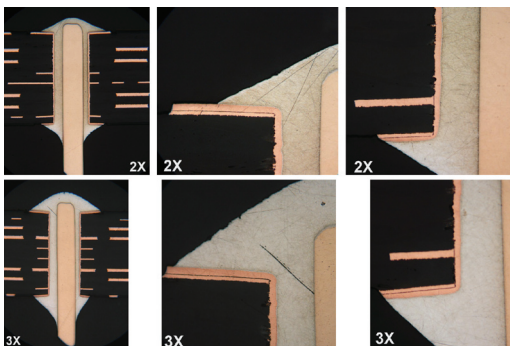
Figure 6. Topside sections of practice board 2 2X and 3X rework.

bottom pad copper and knee copper were less on practice board 1 as compared with practice board 2, which was not anticipated because the solder fountain contact time on practice board 2 was lower. However, based on the copper thickness of the top layer pad copper and bottom layer trace copper, it appears practice board 1 had more copper prior to the start of the rework as compared with practice board 2, and this would explain the results. Figure 6 shows cross-sections of the 2X and 3X rework. The 2X or 3X figure in the lower part of the image denotes the respective rework.

The 2X and 3X rework cross-sections were acceptable per IPC Class 3 criteria. Copper dissolution was acceptable, and the small amount of pad lifting is consistent with SnPb through-hole rework. Solder flow-through to the topside was 100%; there was minimal voiding; wetting was good, and there was no laminate thermal degradation.

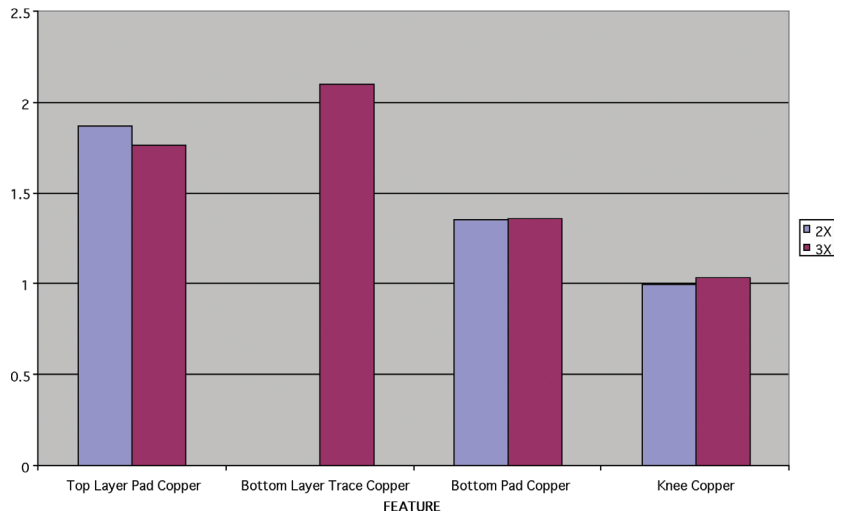
Figure 5. Copper thickness for practice board 2 (OSP) 2X and 3 sites. (Note: The 2x thickness for the bottom layer trace copper was not available.)

2X	3X
Top layer pad copper	1.872	1.764
Bottom layer trace copper	NA	2.103
Bottom pad copper	1.357	1.364
Knee copper	1.001	1.035

PWB copper thickness was measured (Figure 5 and Table 2). The top layer pad copper is on the board top; masking covers the bottom pad copper. Both have negligible risk of copper dissolution and can be considered baselines for the original copper PWB thickness. All measurements are in mils.

The measured results were acceptable for 2X and 3X reworks per IPC Class 3 criteria. The copper thickness at the knees did not go below 0.001", and the amount of copper dissolution on 2X and 3X reworks was equivalent, which was somewhat surprising. It was anticipated the dissolution would increase on the 3X rework as compared with the 2X. The final copper thickness on the

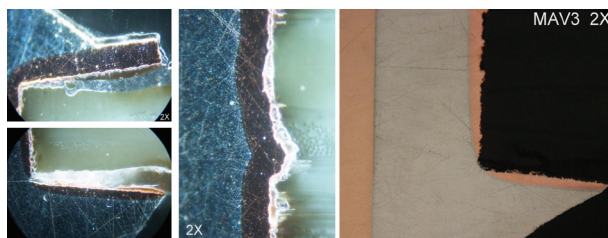
Figure 9. Cross-sections of 16-pin header on Maverick Card 3 after double rework on the solder fountain.

Contact time for each rework is defined as the total time required to remove a component and install a new one while the solder is making continuous contact with the board bottom. The contact time for the original assembly was 9 sec., which means the total contact time for assembly and rework was 49 sec. Cross-section results are shown in **Figure 9**.

The double rework was not acceptable because of the fractured knee caused by copper dissolution because of excessive contact with the molten SAC 305 solder. This is a known risk with Pb-free SAC 305 rework and has been documented.^{3,4} This board would have to be scrapped, which could have significant cost and delivery implications. It should be noted that the fractured knee could not be detected with visual inspection and required destructive cross-sections to see it. The board also exhibited through-hole pull away, which is not acceptable and exhibited undesirable pad lifting.

The Maverick Card is a more thermally massive card as compared with the practice boards and required longer contact times on the solder fountain, which likely caused the unacceptable copper dissolution.

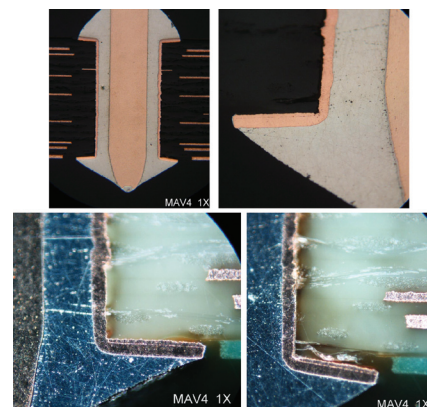
Figure 10. Cross-section of 16-pin header on Maverick Card 4 after single rework using forced convection in conjunction with the solder fountain.

Cross-section results are shown in **Figure 10**.

The single rework was successful in minimizing copper dissolution, but induced some PCB thermal degradation, as manifested by pad lifting and hole pull away. The pad lifting varied from none to a maximum of 0.002", as seen in the two bottom images of Figure 10. The hole pull away was less than 10% along the entire length. It was believed the thermal degradation was most likely caused by the high topside preheat (180°C) in conjunction with the time required at this temperature to reflow the component, remove the component and vacuum the holes. The high PCB preheat temperature was required to minimize melting of the plastic PTH component body; a lower preheat would have been used had the PTH component been rated to a higher temperature. A contributing factor was likely the four reflow cycles required during the original assembly, which, in order, were bottomside Pb-free, topside Pb-free, bottomside SnPb and topside SnPb.

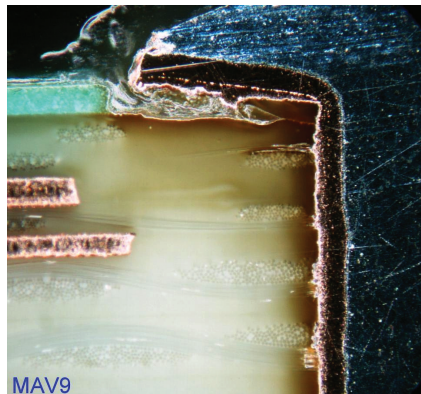
Figure 13. Cross-section of 16-pin header on Maverick Card 9 after double rework using forced convection in conjunction with the solder fountain (top view showing pad lift).

The process dramatically reduced copper dissolution as compared with the process used for Maverick Card 3. The solder fill was greater than 75% as required for IPC-610 Class 3; wetting was good and voiding was minimal. Slight pad lifting was detected, likely related to the high PCB preheat temperature required to compensate for the

low temperature rating of the 16-pin header. Also, this card was subjected to a double BGA rework prior to through-hole rework, and the card was reflowed four times during the original assembly. The increased number of thermal cycles was likely a factor in thermal degradation. Standard Pb-free boards would be reflowed only twice during the original assembly; it is unlikely four reworks would be performed on the same board.

Additional optimization is required to minimize pad lifting.

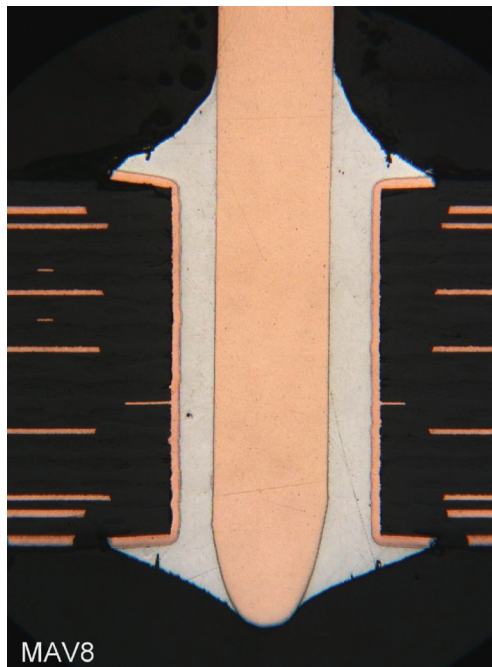
Figure 15. Cross-section of 16-header on Maverick Card 8 after double rework using forced convection in conjunction with the solder fountain (full view).

Maverick Card 8 – ENIG surface finish, double rework with forced convection in conjunction with the solder fountain. The double rework technique used for Maverick Card 9 was used for Maverick Card 8, which had an ENIG surface finish. **Figure 15** shows the cross-section. The joint meets IPC Class 3 Criteria, but there is evidence of slight pad lifting, which is not preferred. The thermal degradation was likely caused by factors similar to those in Maverick Card 9. Copper dissolution on Maverick Card 8 was not an issue, as anticipated given the ENIG PCB surface finish.
