### Transition to Lead Free Electronics Assembly Case Study – Part II Product Reliability and Forced Rework

Robert Farrell, Scott Mazur, and Paul Bodmer Benchmark Electronics, Hudson NH Richard Russo, Mercury Computer Systems, Chelmsford MA Gregory Morose, Massachusetts Toxics Use Reduction Institute, Lowell MA

This paper is an extension of Part I and will include reliability results obtained from thermal cycling It will also include the results from the forced rework of BGAs and a through-hole component.

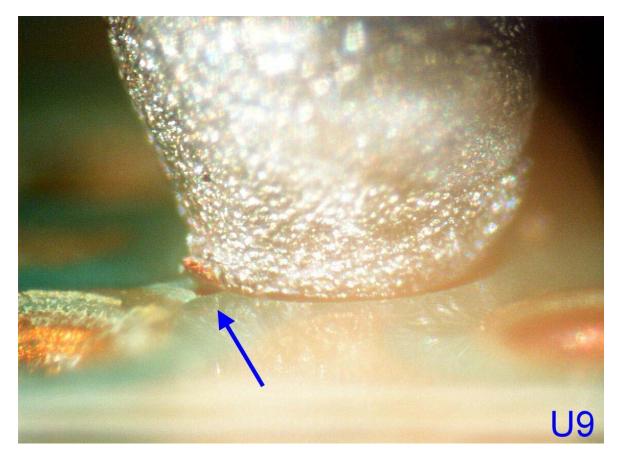
Failure Mode 2: Ceramic BGA at U9, 360 Spheres, 1.00 mm Pitch

Similar to Failure Mode 1, a CTE mismatch placed stress in the corner joints. The sphere to PCB pad interface remained intact but as additional pads lifted increased stress was placed on a PCB etch emanating from a corner pad. This caused the PCB etch to fracture which can be seen in Figure 3. This failure differs from the equivalent type of Ceramic BGA failure on a SnPb assembly in which the stress normally causes a fracture in the bulk solder of the joints.

Figure 3 - Failure Mode 2 on the Maverick Card that Failed Thermal Cycling Between the 400<sup>th</sup> and 500<sup>th</sup> Cycle Location is Ceramic BGA at U9 and the Arrow Denotes the Fractured PCB Trace.

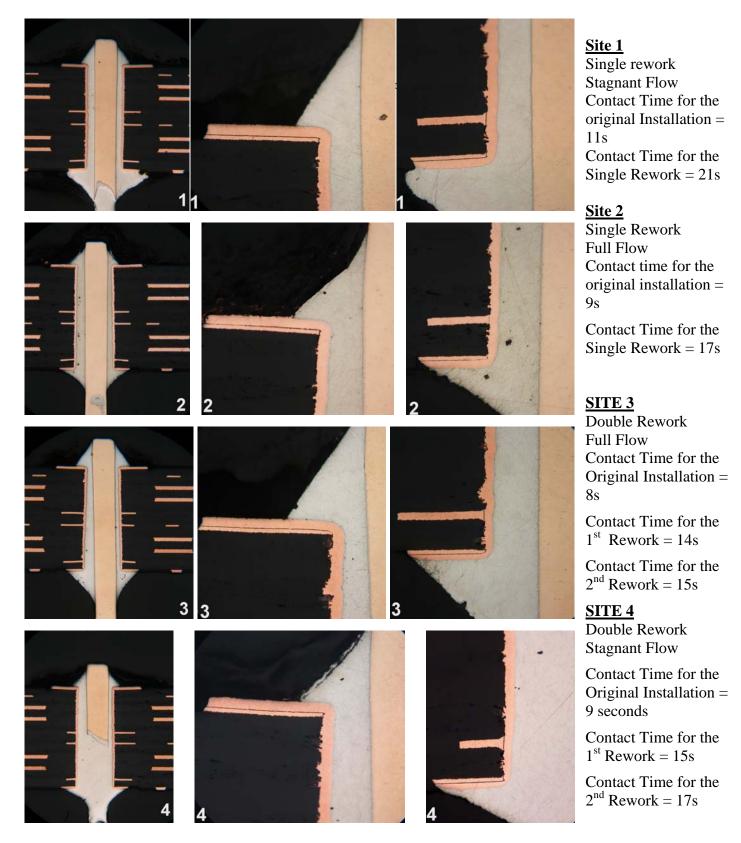
Figure 6 - Cross Section and Process Summary for Sites 1, 2, 3, & 4 on Practice Board 1 (OSP)

- All four sites were considered acceptable. There were no excessively thin or fractured knees, nor was there any significant via wall thinning near the surface. Copper thickness was above the IPC Class 3 minimum of .001" (1 mil).
- Copper dissolution increased for the double rework as compared with the single rework which was expected but the increase was smaller than anticipated.
- The difference in copper dissolution between the stagnant and full flow was not significant.
- By the end of the double rework process, the bottom side pads have lost approximately one-quarter of their original copper, regardless of method used.

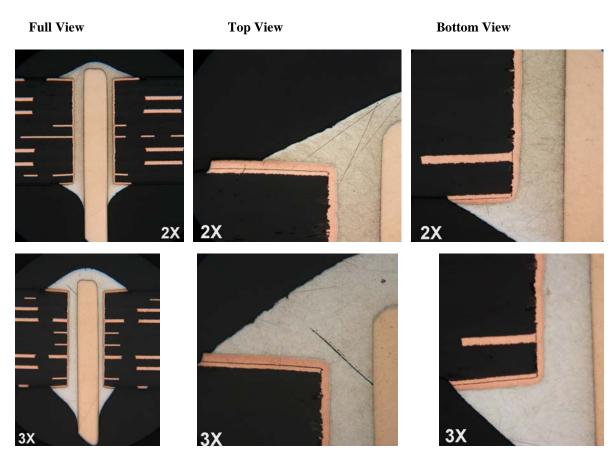
Figure 9 - Cross Sections of the 2X and 3X Rework on Practice Board 2 (OSP)

The cross sections of the 2X and 3X reworks were acceptable per IPC Class 3 criteria. The amount of copper dissolution was acceptable and the small amount of pad lifting is consistent with SnPb through hole reworks. The flow through of solder to the topside was 100%, there was minimal voiding, the wetting was good, and there was no thermal degradation of the laminate.

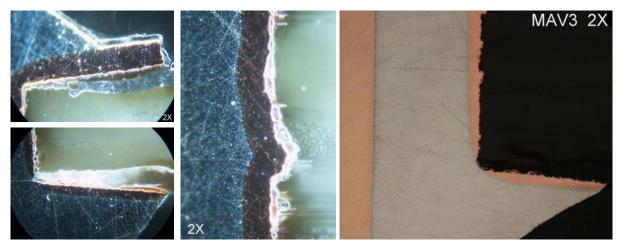
PAD LIFTING HOLE WALL PULL-AWAY

FRACTURED KNEES

Here we see significant pad lifting on both sides of the board, as well as hole wall pull-away.

The knees are fractured; one is seen in the bright field. image at the left.

This process was not successful.

### Figure 12 - Cross Section of the 16 Pin Header on the Maverick Card #3 (OSP) after Double Rework on the Solder Fountain

The double rework was not acceptable per IPC Class 3 Criteria, and the fractured knees caused by copper dissolution is a known risk of Pb-free SAC305 rework and it has been documented previously. It should be noted the fractured knee could not be detected with visual inspection and required destructive cross sections for detection.

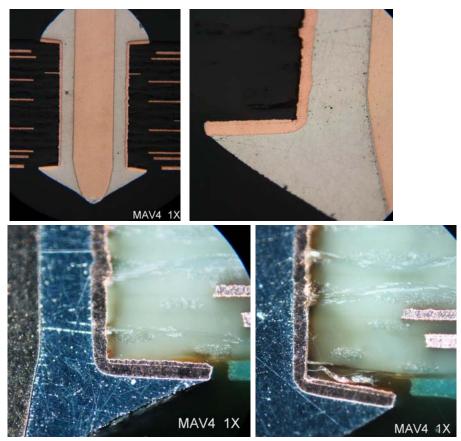
The single rework process was more benign to the board. As we see in these images, the knees remained intact and the copper is in generally much better shape than we saw with the double rework process.

There was still some degree of pad lifting, as noted in the two images at the bottom. However, it varied from none at all to about 2 mils, across the section.

Hole wall pull-away was less than 10% along the length of the via wall.

This was a successful rework that produced acceptable results. With fine tuning, it may be possible to eliminate most of the observable pad lifting.

Figure 13 - Cross Section of the 16 Pin Header on the Maverick Card #4 (OSP) after Single Rework (Removal by Hot Air and Installation by Solder Fountain)

The single rework was successful in minimizing copper dissolution but induced some PCB thermal degradation. It was believed this was most likely caused by the high topside preheat (180 degrees C) combined with the extended time at this temperature required to reflow the component, remove the component, and vacuum the holes. The higher temperature was required to minimize the melting of the through-hole component and the profile would have been optimized if the through hole component was rated to a higher temperature.

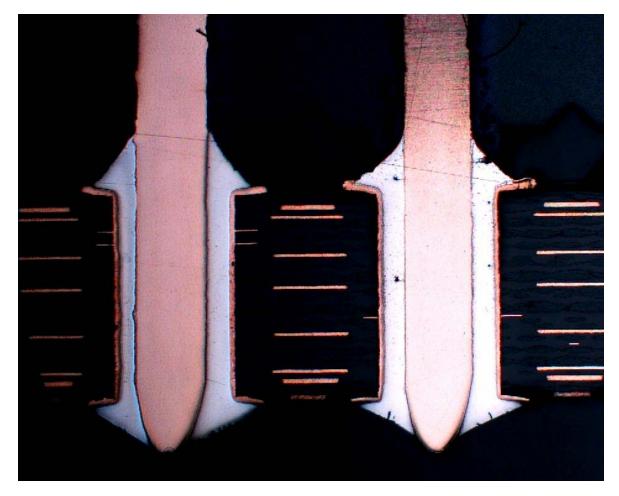
Figure 14 - Cross Section of the 16 Pin Header on the Maverick Card #9 (OSP) after Double Rework (Removal = Hot Air and Installation = Solder Fountain) Full View.

The technique significantly reduced copper dissolution as compared with the technique used for Maverick Card # 3. Flow through of solder to Side 1 was greater than 75%, wetting was good, and voiding was minimal. However, slight pad lifting was detected which may be related to the high board preheat temperature required for the low temperature rating of the through hole component being reworked. Moreover, this card was previously subjected to a double BGA rework prior to the double through hole rework and the increased number of thermal cycles may have also been a factor.

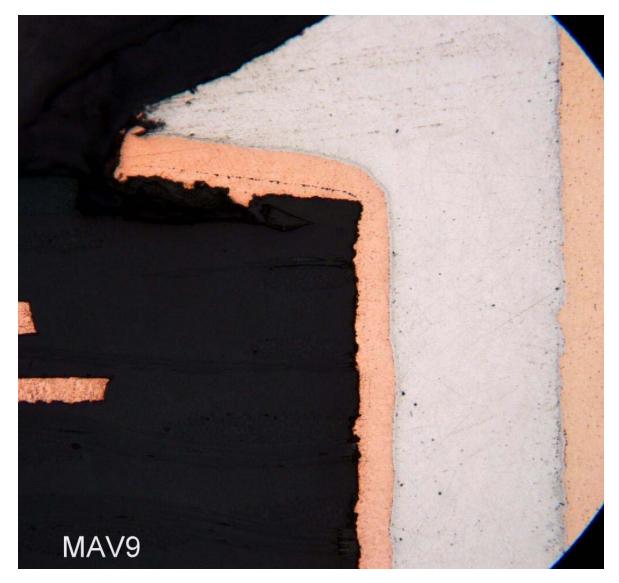
Figure 15 - Cross Section of the 16 Pin Header on the Maverick Card #9 (OSP) after Double Rework. Top View.

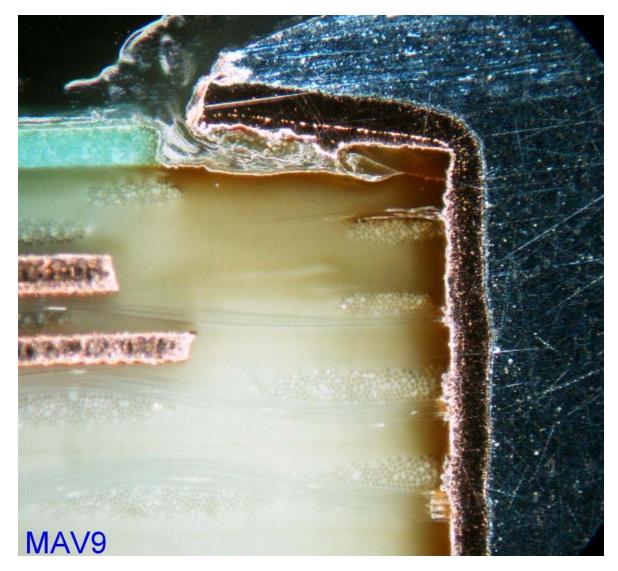
Figure 16 - Cross Section of the 16 Pin Header on the Maverick Card #9 (OSP) after Double Rework. Top View Showing Pad Lift.

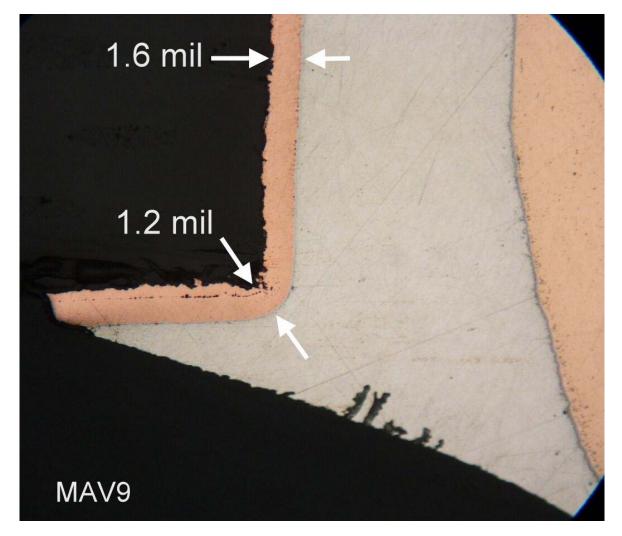
Figure 17 - Cross Section of the 16 Pin Header on the Maverick Card #9 (OSP) after Double Rework. Bottom View Showing Copper Thickness at the Knee.

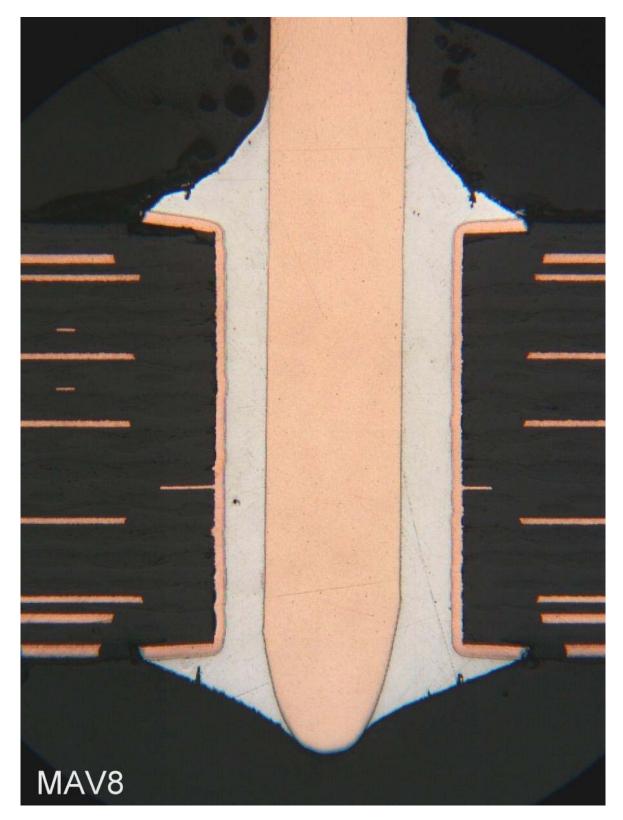
Figure 18 - Cross Section of the 16 Pin Header on the Maverick Card #8 (ENIG) after Double Rework. Full View.

The joint in Figure 18 meets IPC Class 3 Criteria, but there is evidence of slight pad lifting which is not preferred. Copper dissolution was not an issue with ENIG surface finish.

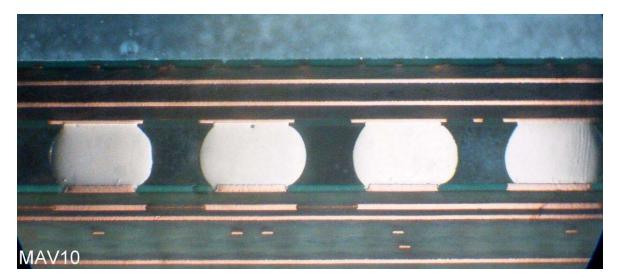
A double rework was preformed in a similar fashion on the 304 Pin BGA on Maverick Card # 10 which had an ENIG surface finish. There was no evidence of thermal degradation and the BGA joints met IPC Class 3 criteria. A representative cross section appears in Figure 21.

Figure 21 - Maverick Card #10 Double Rework on the Maverick Card ENIG, 304 Pin BGA at U29.

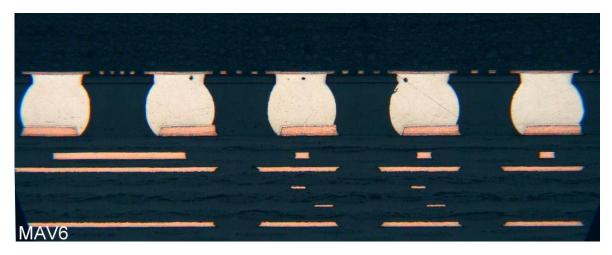
A double rework was preformed in a similar fashion on the 280 Pin BGA on Maverick Card # 6 which had an ImAg surface finish. There was no evidence of thermal degradation and the BGA joints met IPC Class 3 criteria. A representative cross section appears in Figure 22.

Figure 22 - Maverick Card #6 Double Rework on the Maverick Card ImAg, 304 Pin BGA at U510.

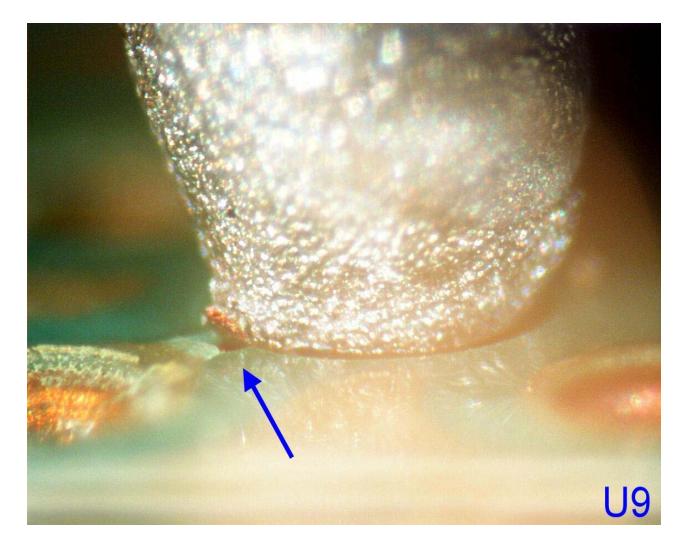
## Broken Etch at Corner of Ceramic BGA (post thermal cycling)

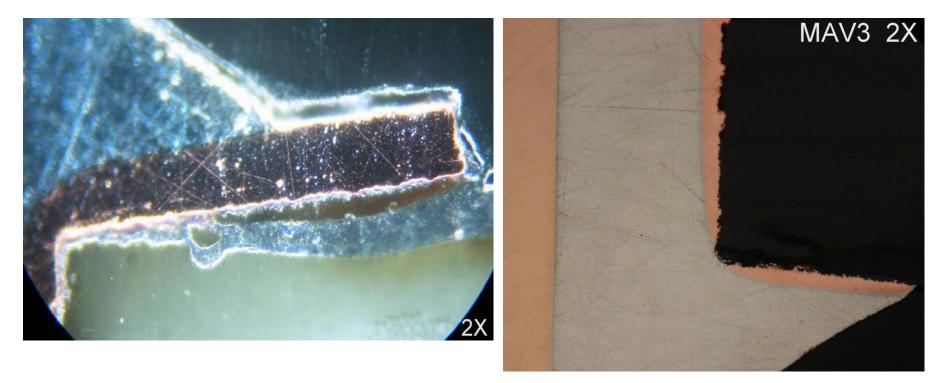
# Results for the Maverick OSP Card # 3 Double Rework (Unacceptable)

Top view of the Through Hole Joint

Bottom view showing copper dissolution at the knee

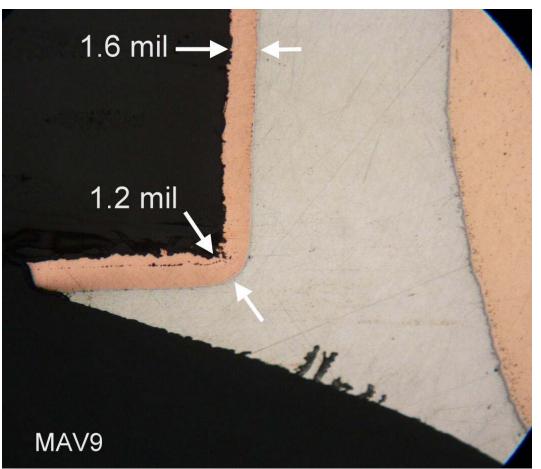
### Results for the Double Rework on Maverick Card #9, OSP (Acceptable Copper Thickness)

Bottom view of through hole joint
