Hex-Chrome Free Sealant Project

Note: This is a revision of MPLR – 101436. This revision includes the test data and analysis of the Beachfront test vehicles after the Beachfront exposure near Daytona Beach.

MPLR – 101436A
June 10, 2014

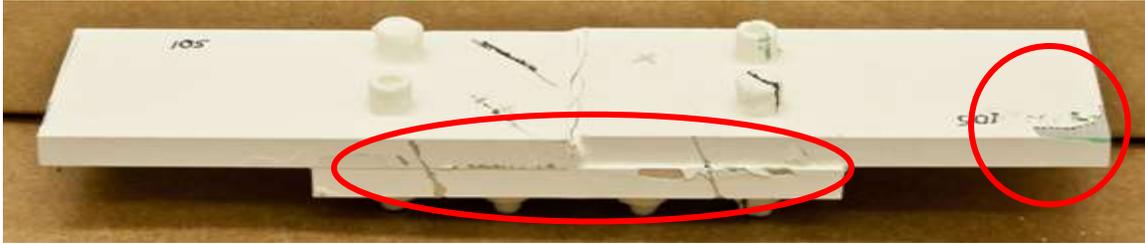
FIGURE 5.2.1.2 ADHESION LOSS ON SIDES AND GRIP AREA OF PRIMED AND TOPCOATED TEST VEHICLE

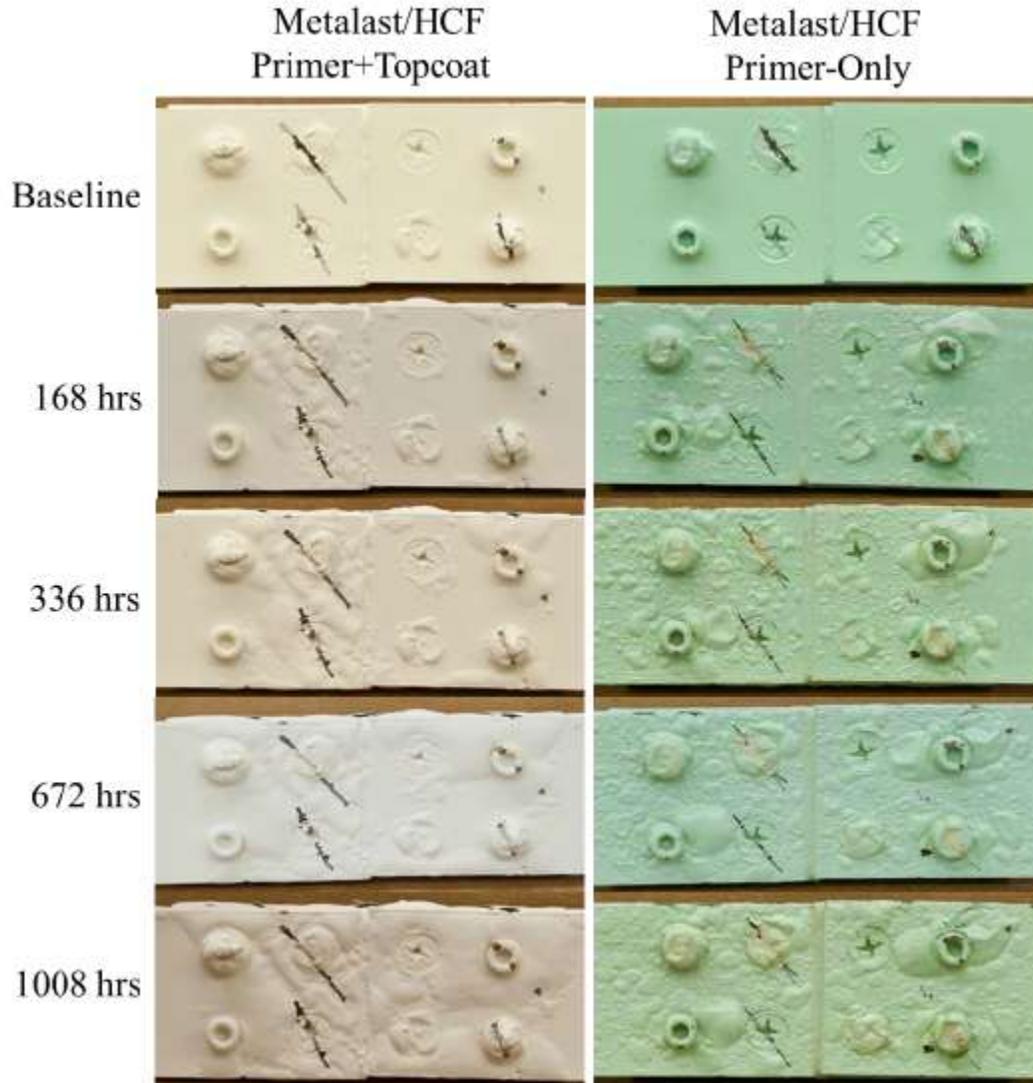
FIGURE 6.1.1 NON-DESTRUCTIVE INSPECTIONS OF 6061-T6 TEST VEHICLES WITH PR-1775

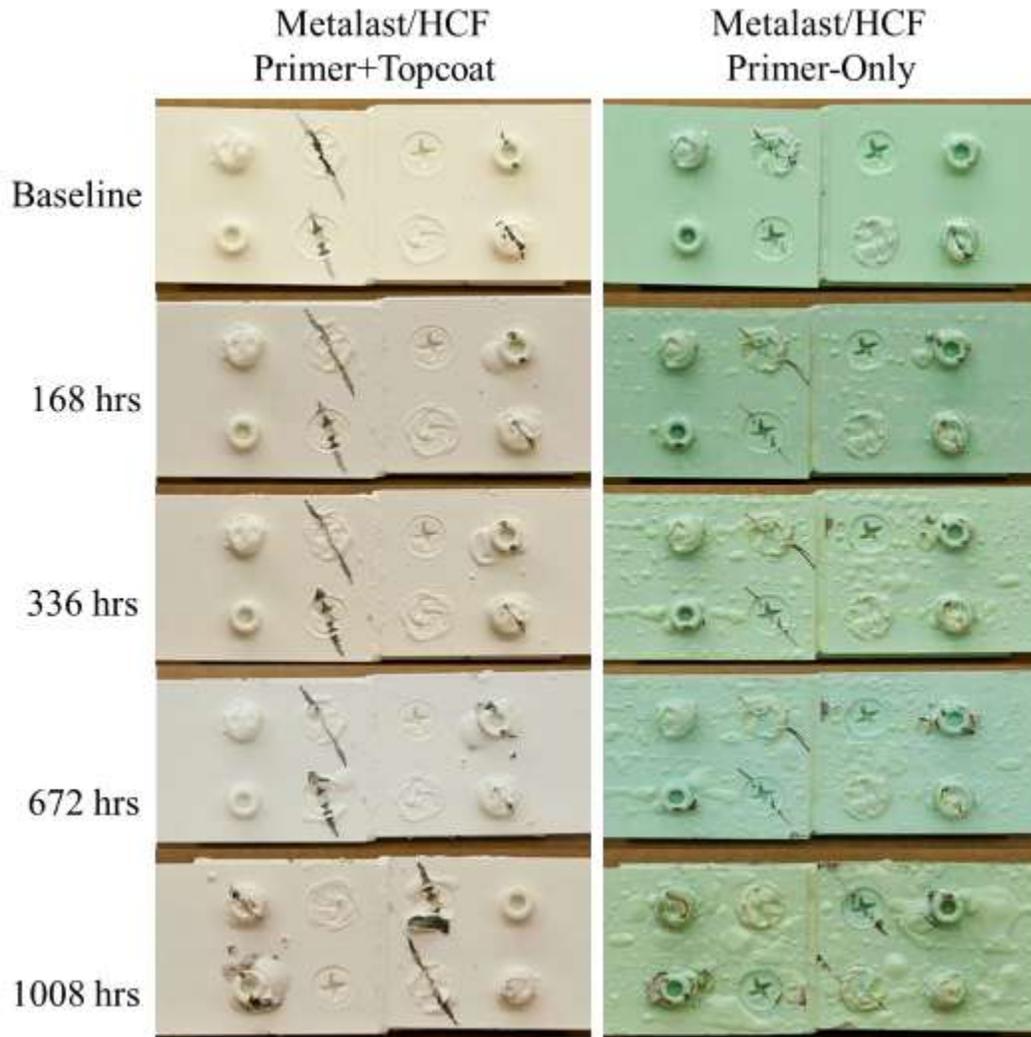
FIGURE 6.1.2 NON-DESTRUCTIVE INSPECTIONS OF 7075-T6 TEST VEHICLES WITH PR-1775

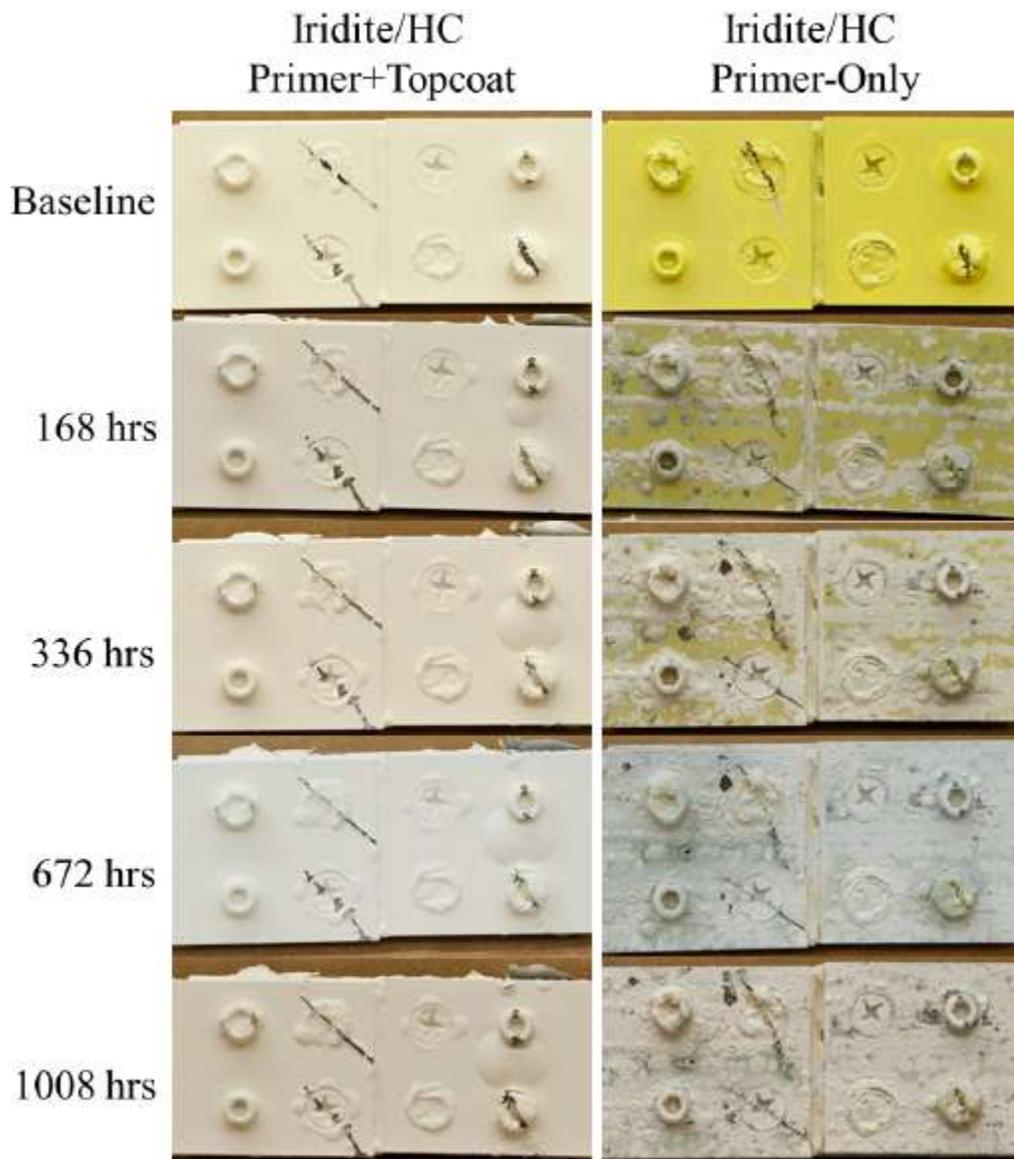
FIGURE 6.1.3 NON-DESTRUCTIVE INSPECTION OF 7075-T6 TEST VEHICLES WITH PR-1775

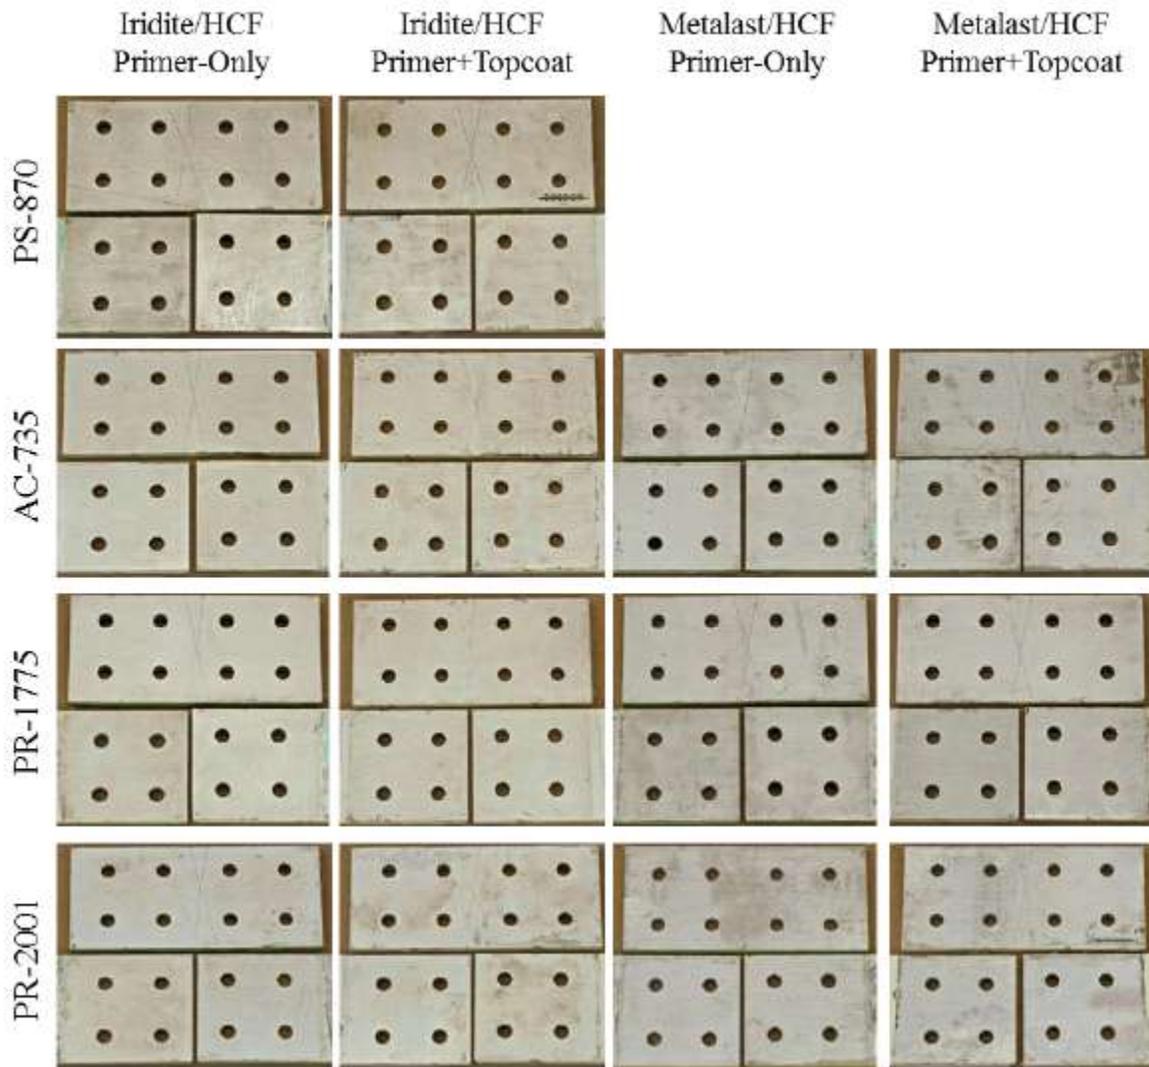
Butt Joints and Faying Surfaces (TVs 1-14)			
6061 with HCF Primer			
Ranking	Sealant	Surf. Prep.	Corrosion
1	PS-870	Iridite	3
	PR-1775	Iridite	5
	PR-1775	Metalast	6
	AC-735	Iridite	6
5	PR-2001	Iridite	16
6	AC-735	Metalast	22
7	PR-2001	Metalast	69

FIGURE 6.2.1 6061-T6 TEST VEHICLE FAYING SURFACES AFTER 1008 HOURS OF EXPOSURE TO SO₂ SALT FOG

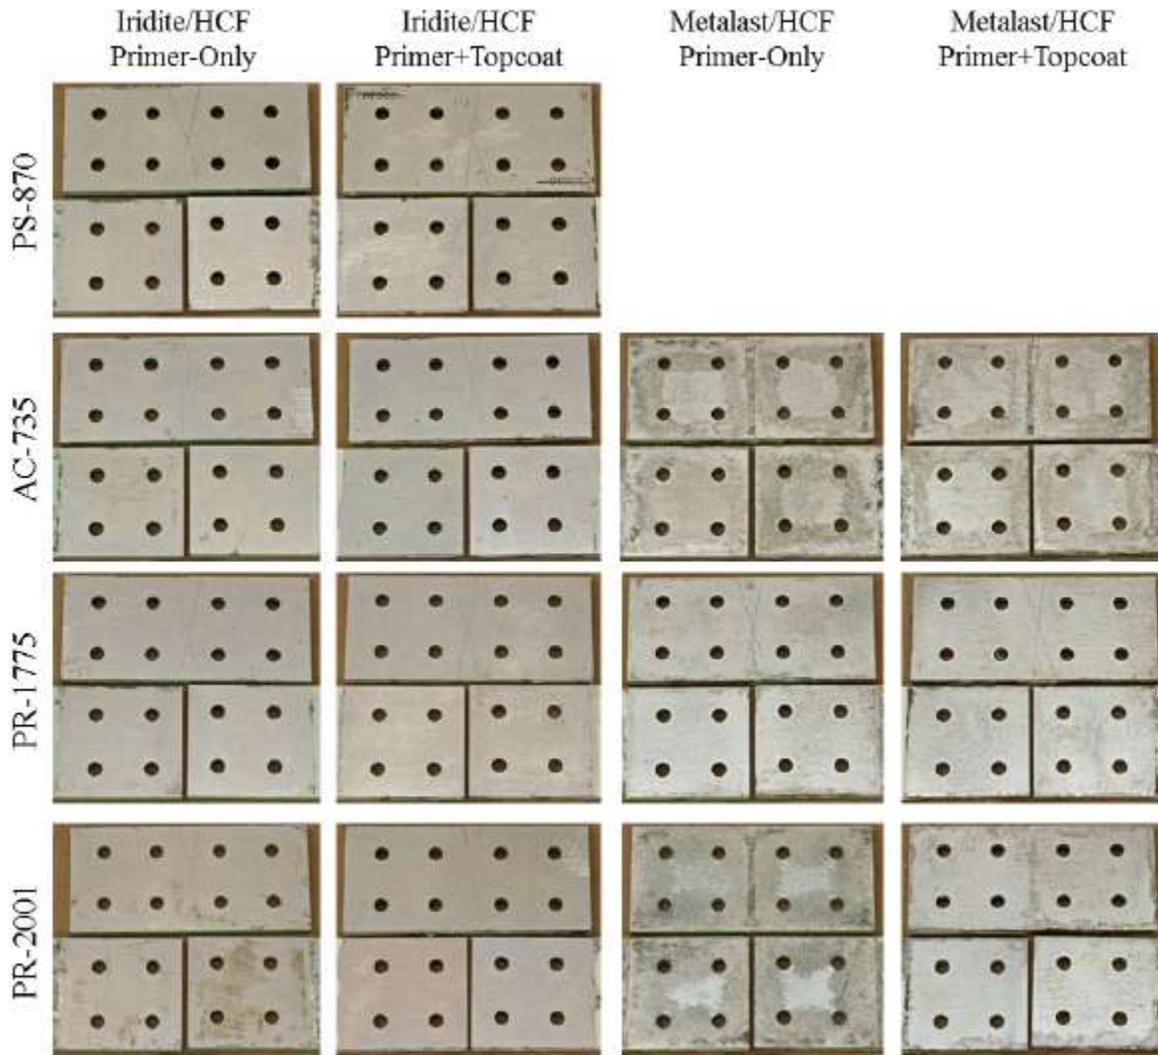
FIGURE 6.2.2 7075-T6 (HCF PRIMER) TEST VEHICLE FAYING SURFACES AFTER 1008 HOURS OF EXPOSURE TO SO₂ SALT FOG

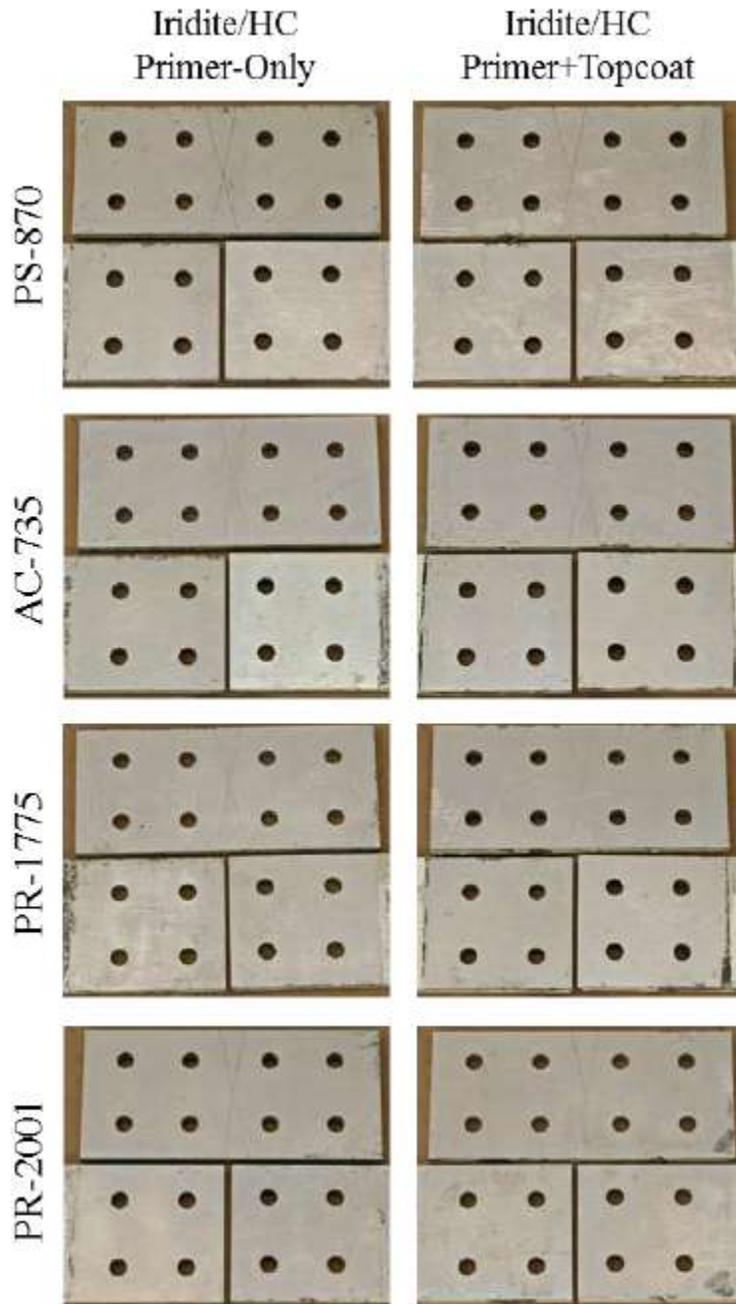
FIGURE 6.2.3 7075-T6 (HC PRIMERS) TEST VEHICLE FAYING SURFACES AFTER 1008 HOURS OF EXPOSURE TO SO₂ SALT FOG

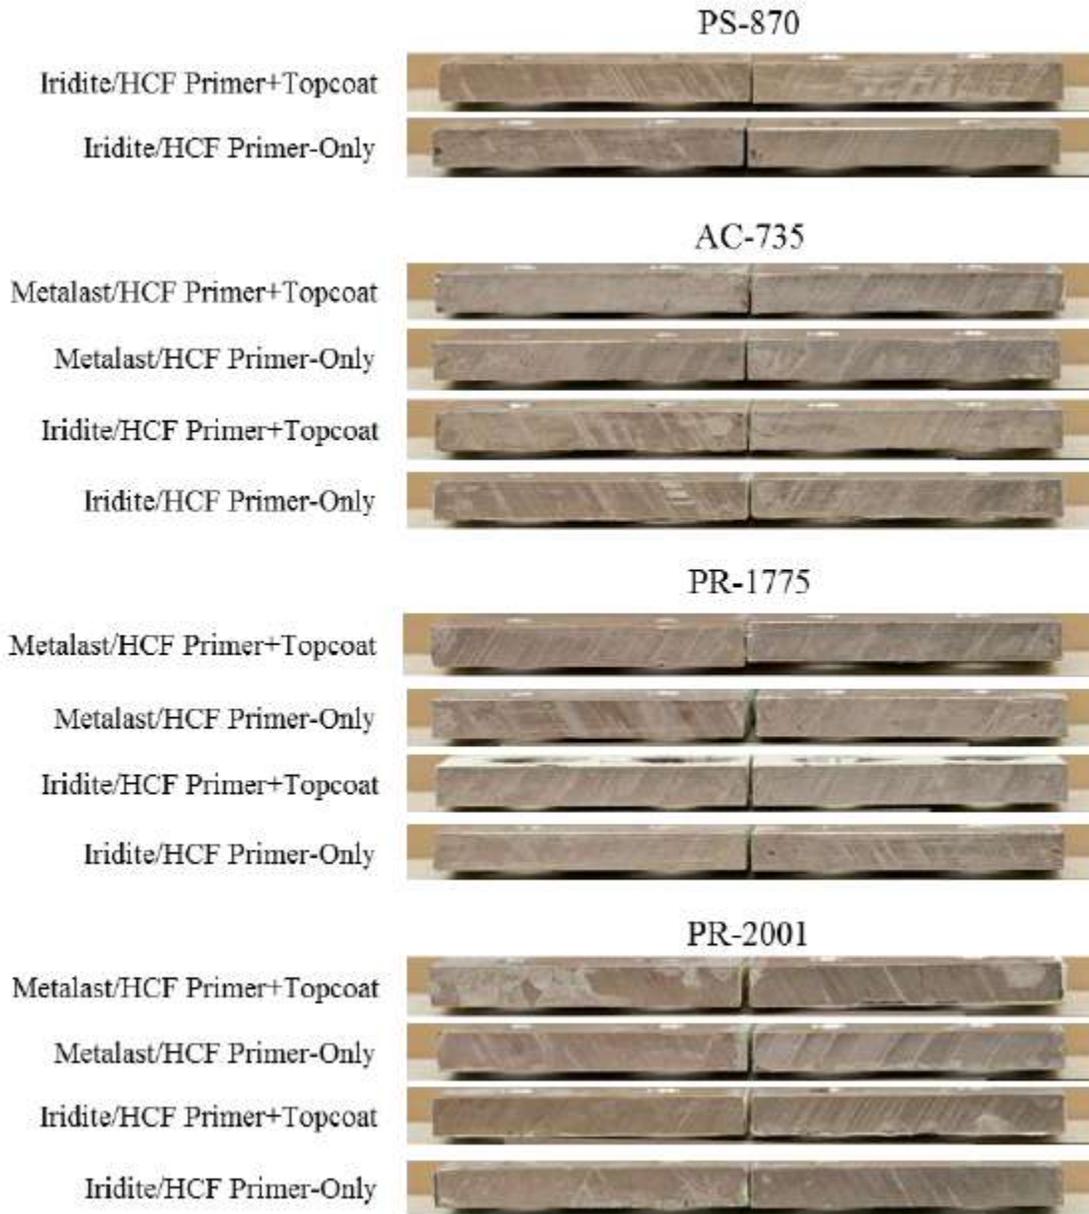
FIGURE 6.2.4 6061-T6 TEST VEHICLE BUTT JOINTS AFTER 1008 HOURS OF EXPOSURE TO SO₂ SALT FOG

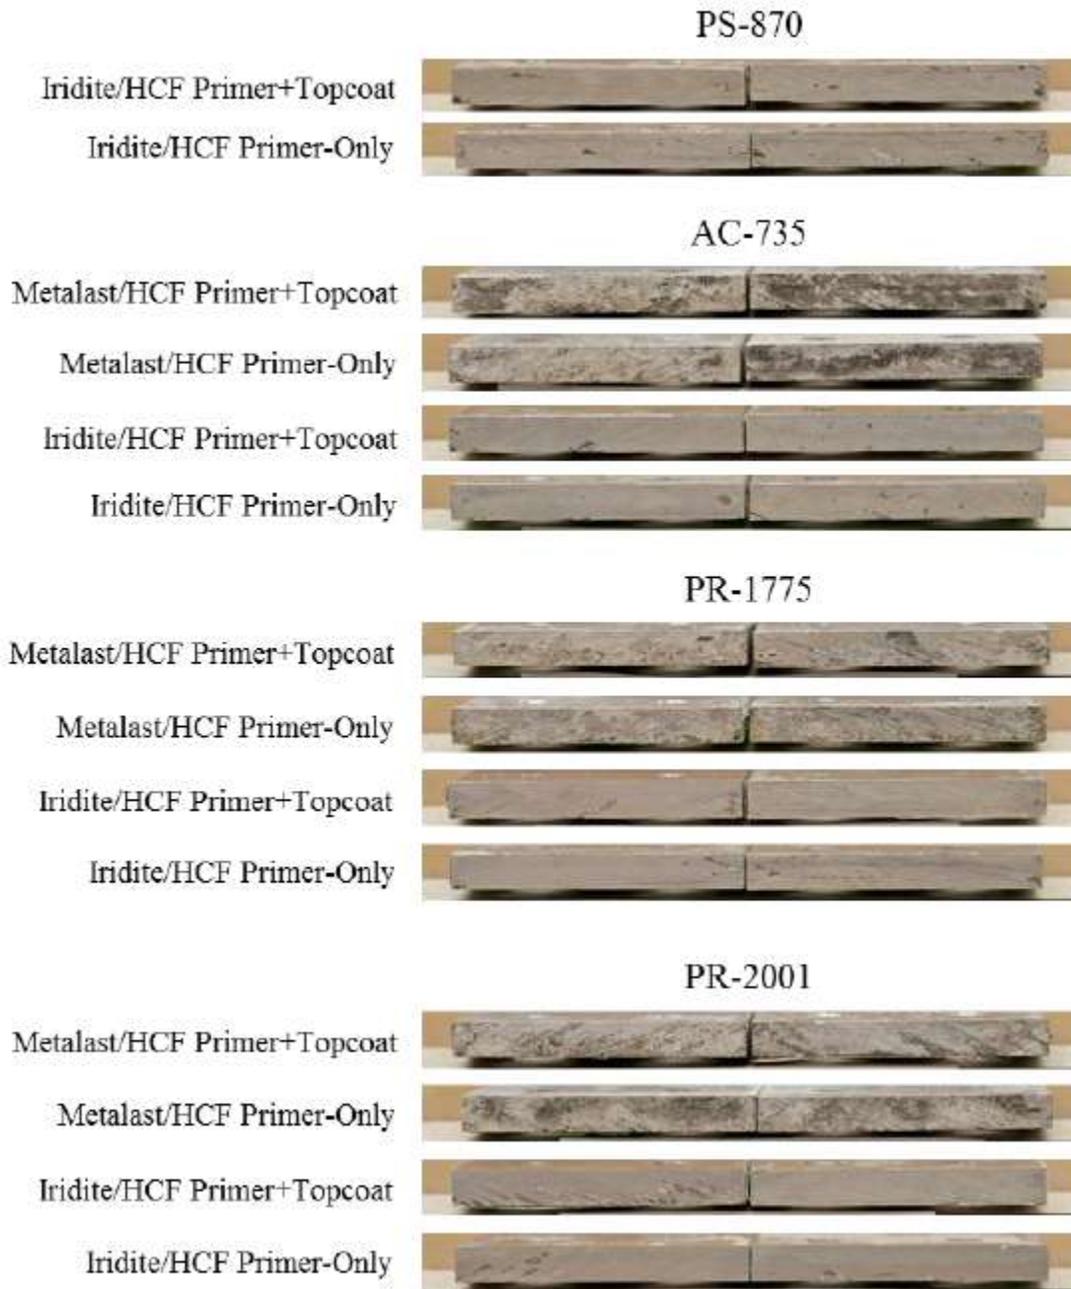
FIGURE 6.2.5 7075-T6 (HCF PRIMERS) TEST VEHICLE BUTT JOINTS AFTER 1008 HOURS OF EXPOSURE TO SO₂ SALT FOG

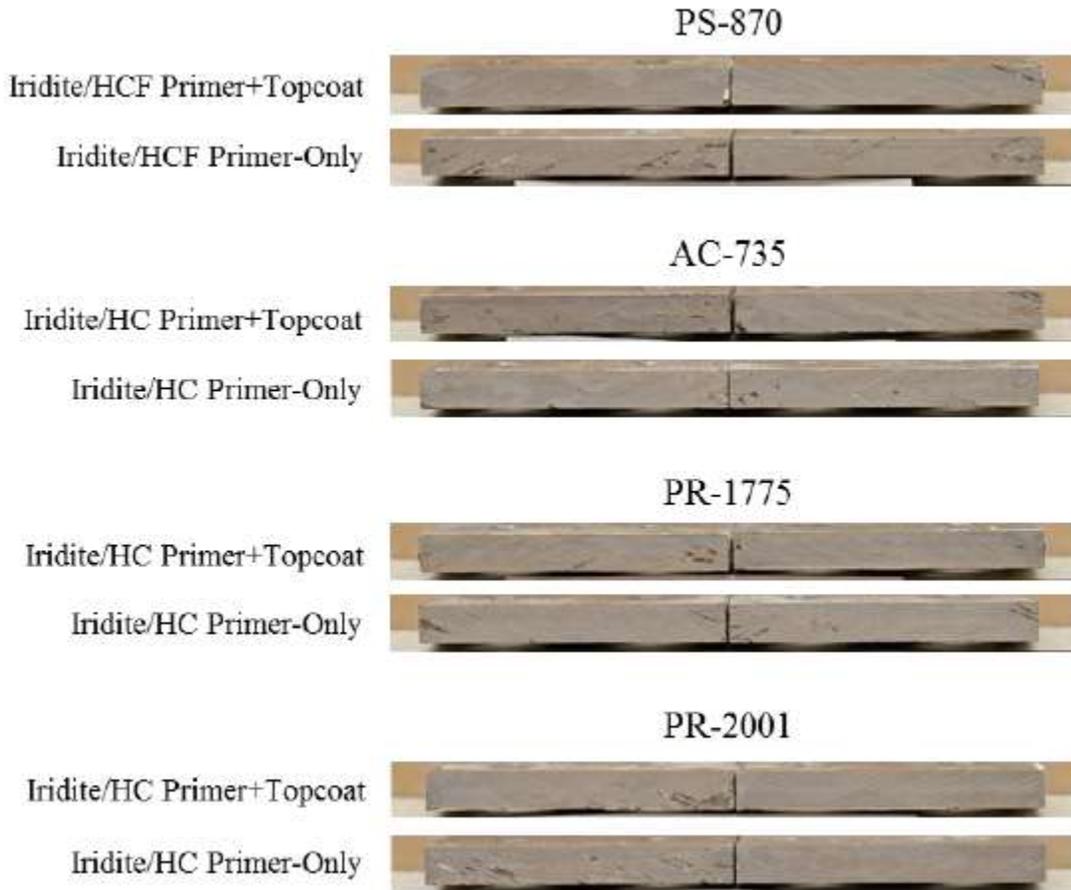
FIGURE 6.2.6 7075-T6 (HC PRIMERS) TEST VEHICLE BUTT JOINTS AFTER 1008 HOURS OF EXPOSURE TO SO₂ SALT FOG

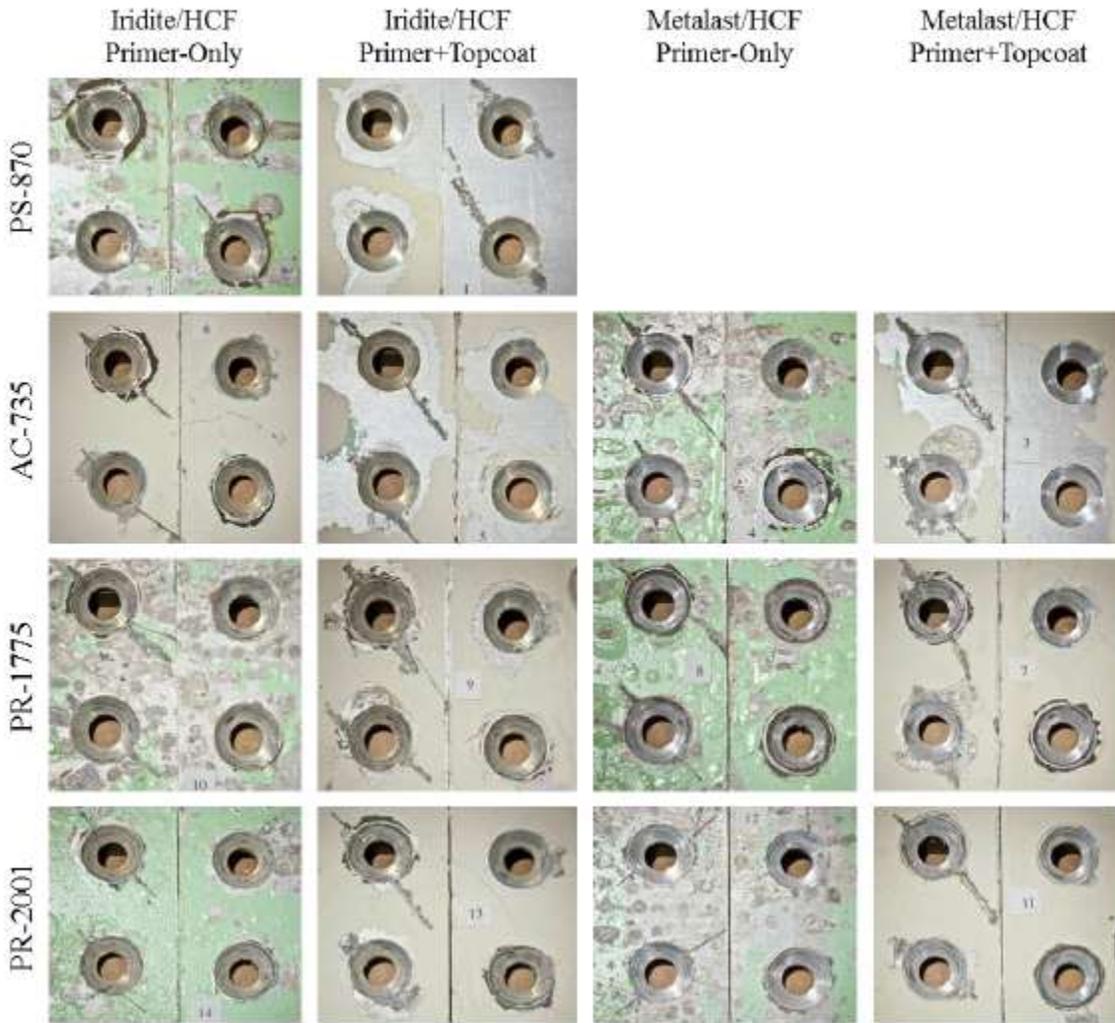
FIGURE 6.2.7 6061-T6 TEST VEHICLE COUNTERSINK AREAS AFTER 1008 HOURS OF EXPOSURE TO SO₂ SALT FOG

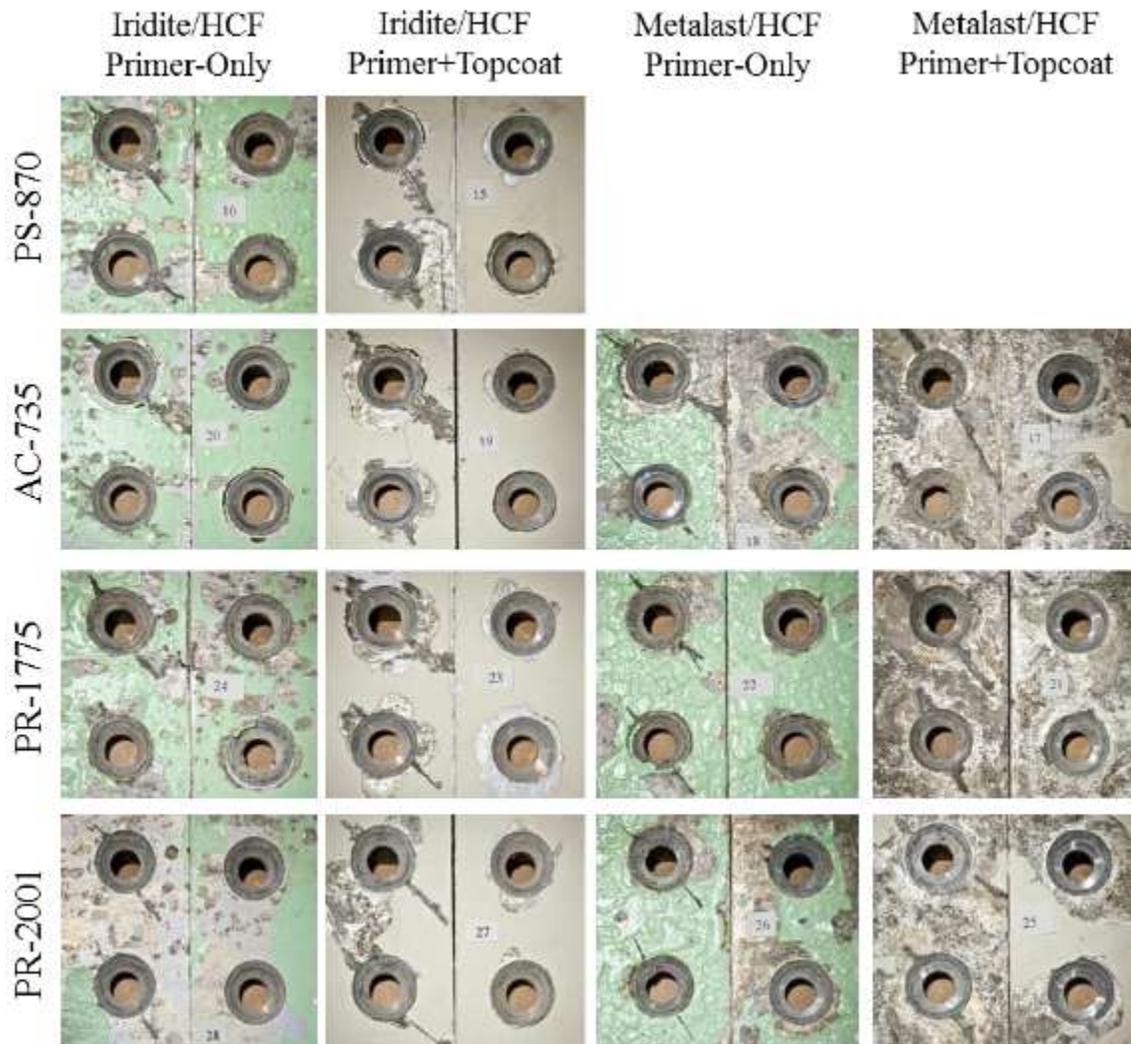
FIGURE 6.2.8 7075-T6 (HCF PRIMERS) TEST VEHICLE COUNTERSINK AREAS AFTER 1008 HOURS OF EXPOSURE TO SO2 SALT FOG

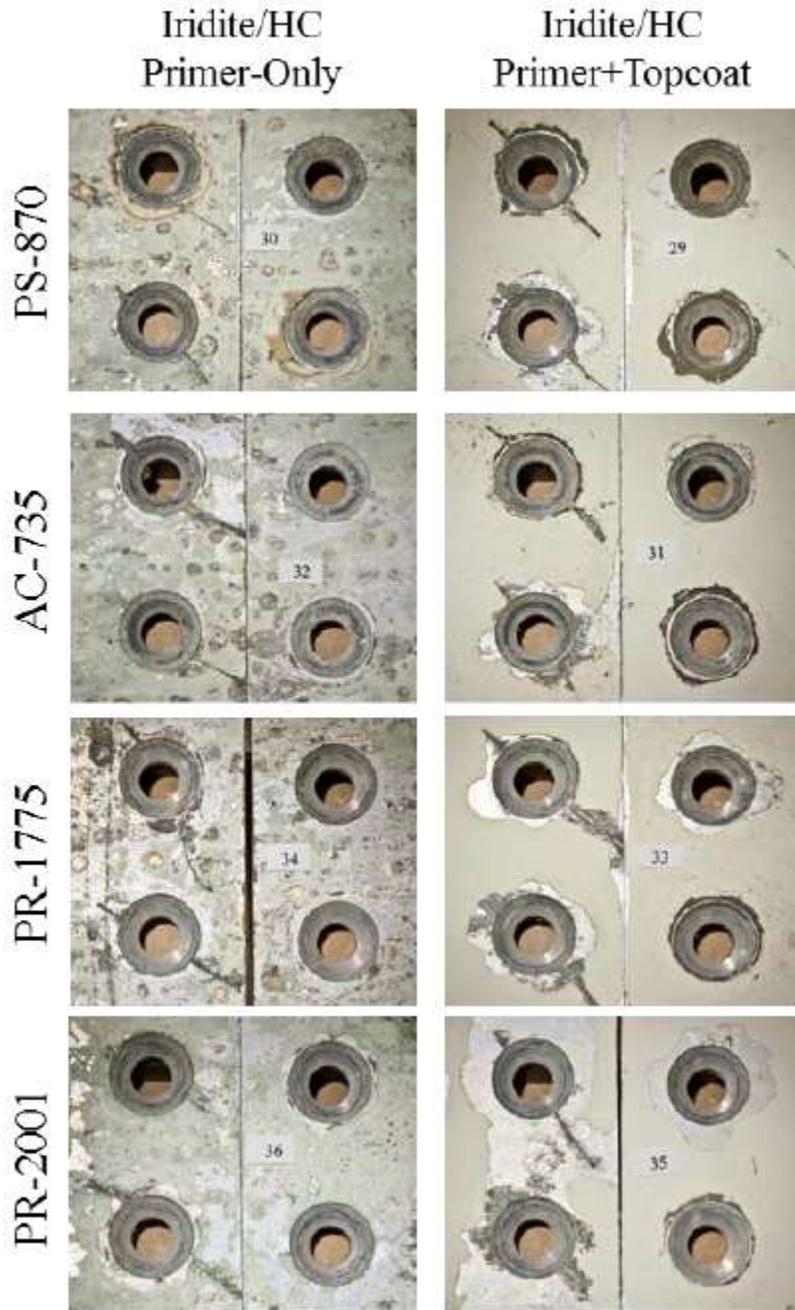
Countersink Areas (TVs 29-36)			
7075 with HC Primer			
Ranking	Sealant	Surf. Prep.	Corrosion
1	PR-1775	Iridite	173
2	PS-870	Iridite	380
3	PR-2001	Iridite	495
4	AC-735	Iridite	625

FIGURE 6.2.9 7075-T6 (HC PRIMERS) TEST VEHICLE COUNTERSINK AREAS AFTER 1008 HOURS OF EXPOSURE TO SO₂ SALT FOG

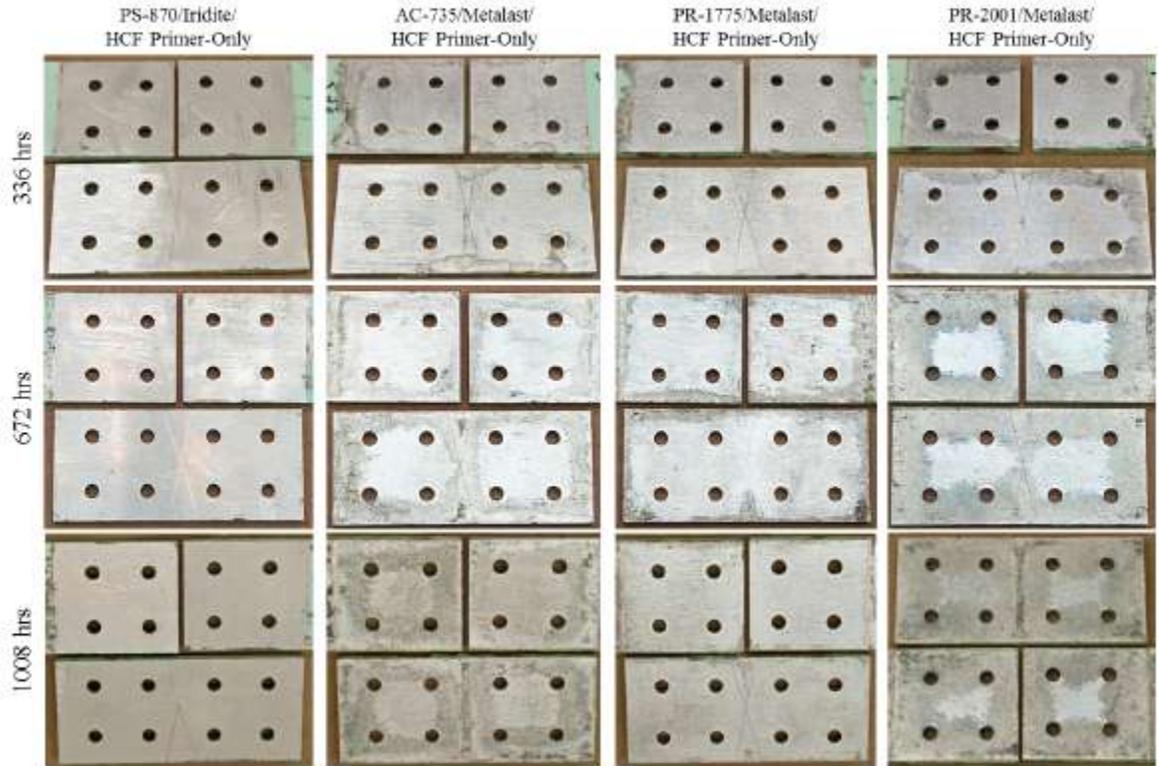
FIGURE 6.2.11 FAYING SURFACES OF 7075-T6 INTERIM TEST VEHICLES AFTER DESTRUCTION

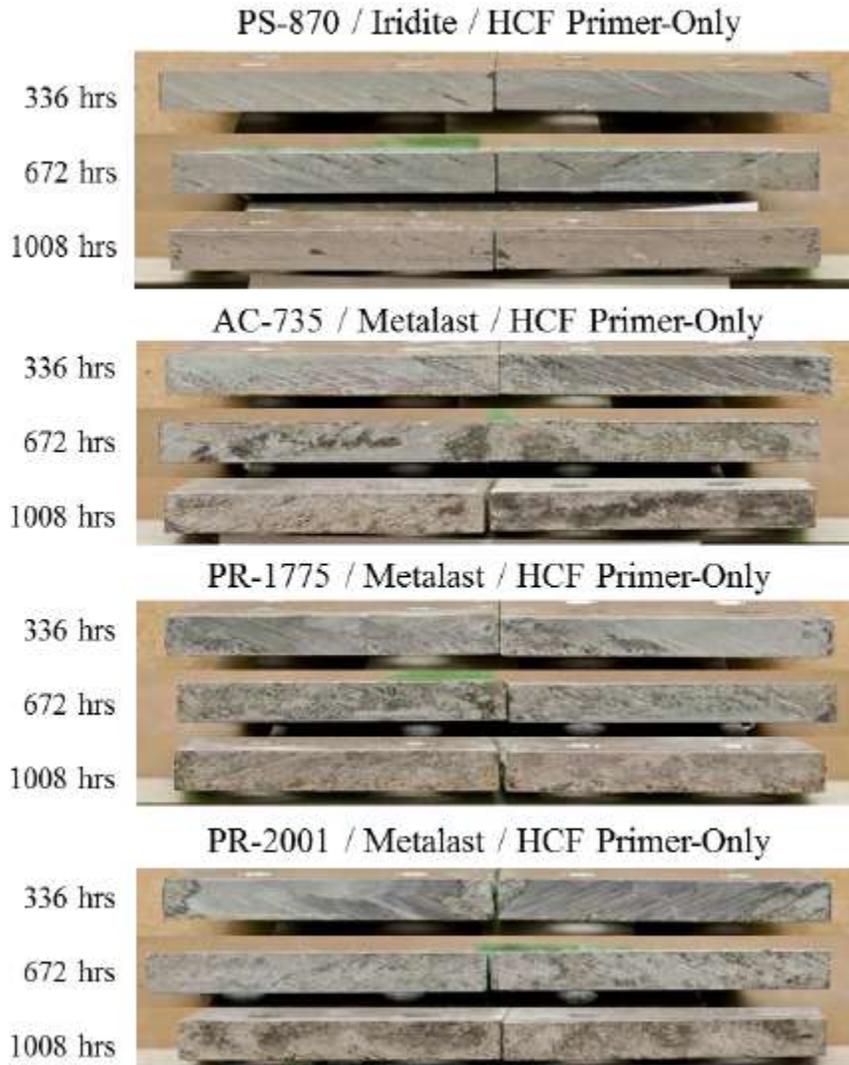
FIGURE 6.2.12 BUTT JOINTS OF 7075-T6 INTERIM TEST VEHICLES
AFTER DESTRUCTION

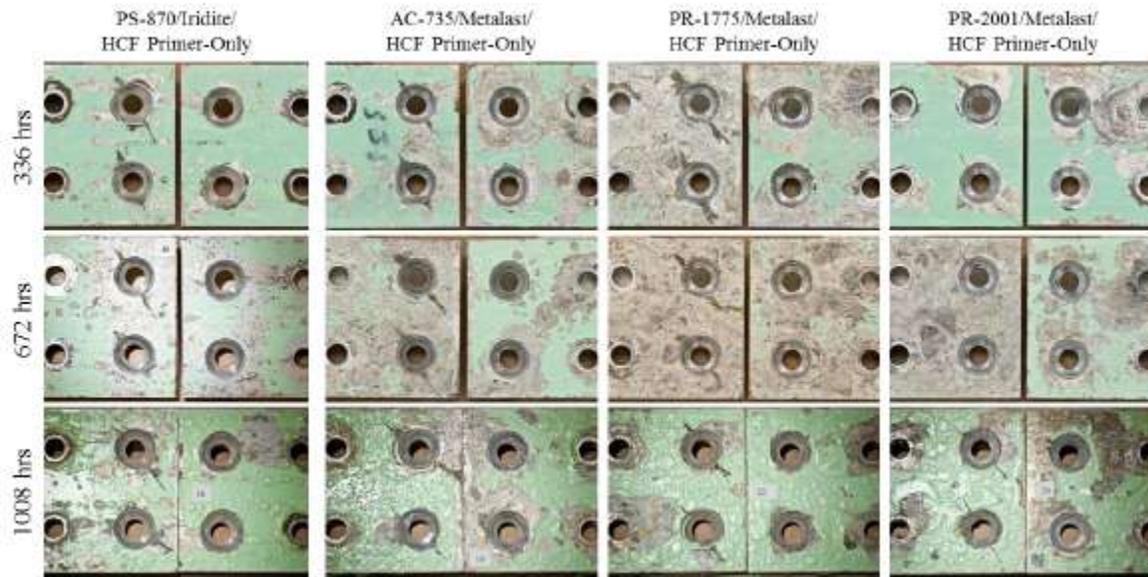
FIGURE 6.2.14 COUNTERSINK HOLES OF 7075-T6 INTERIM TEST VEHICLES AFTER DESTRUCTION

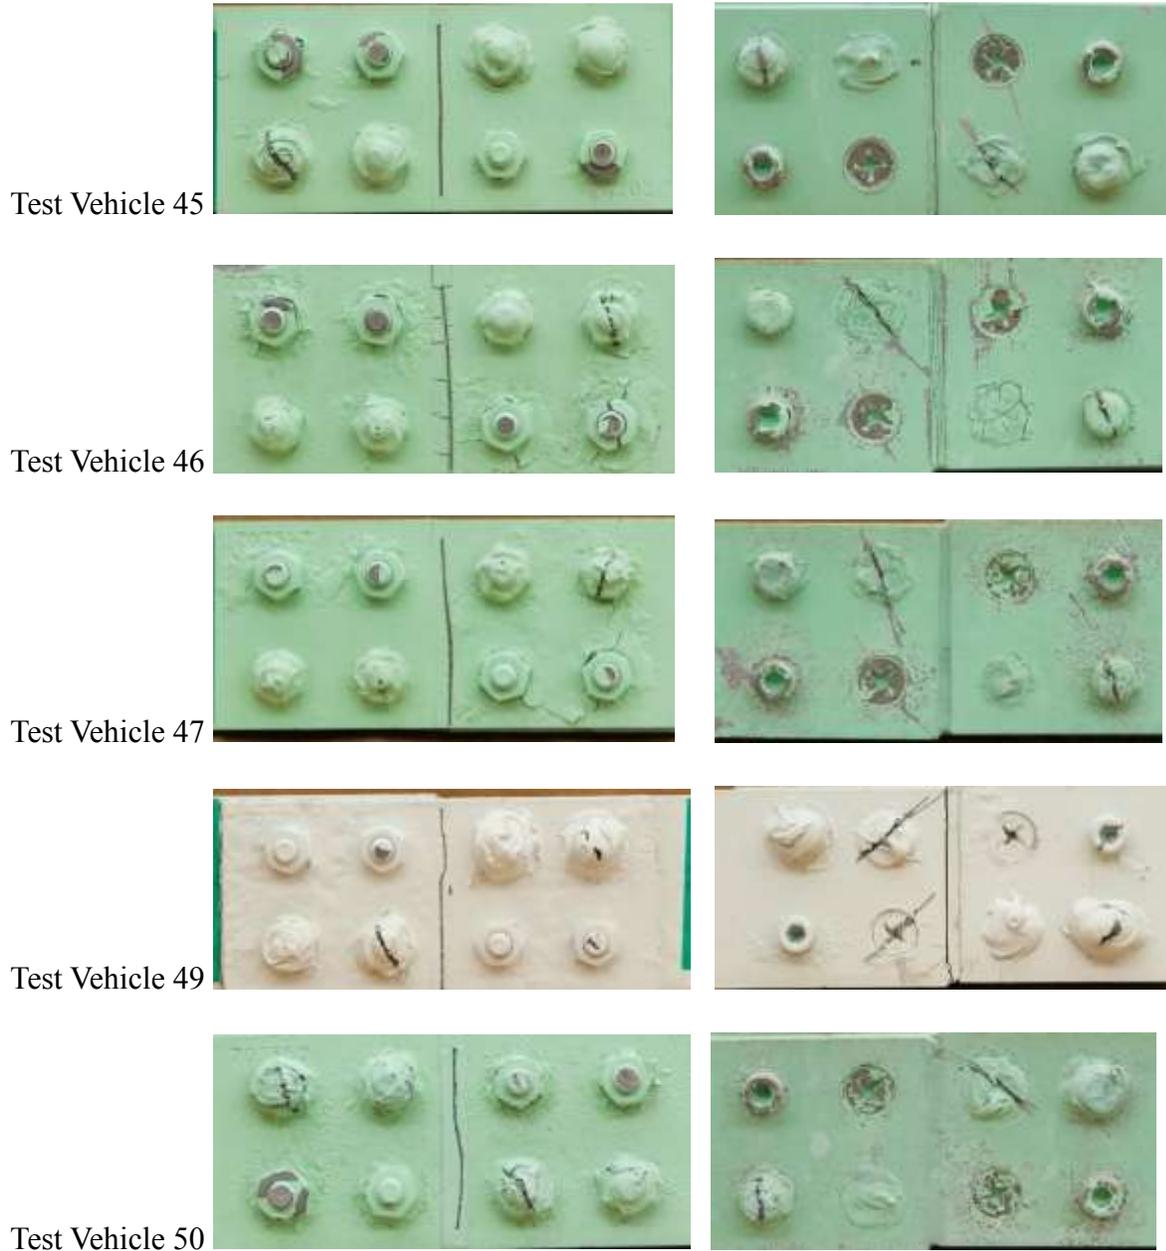
FIGURE A1. SURFACES OF BEACHFRONT COUPONS AFTER EXPOSURE

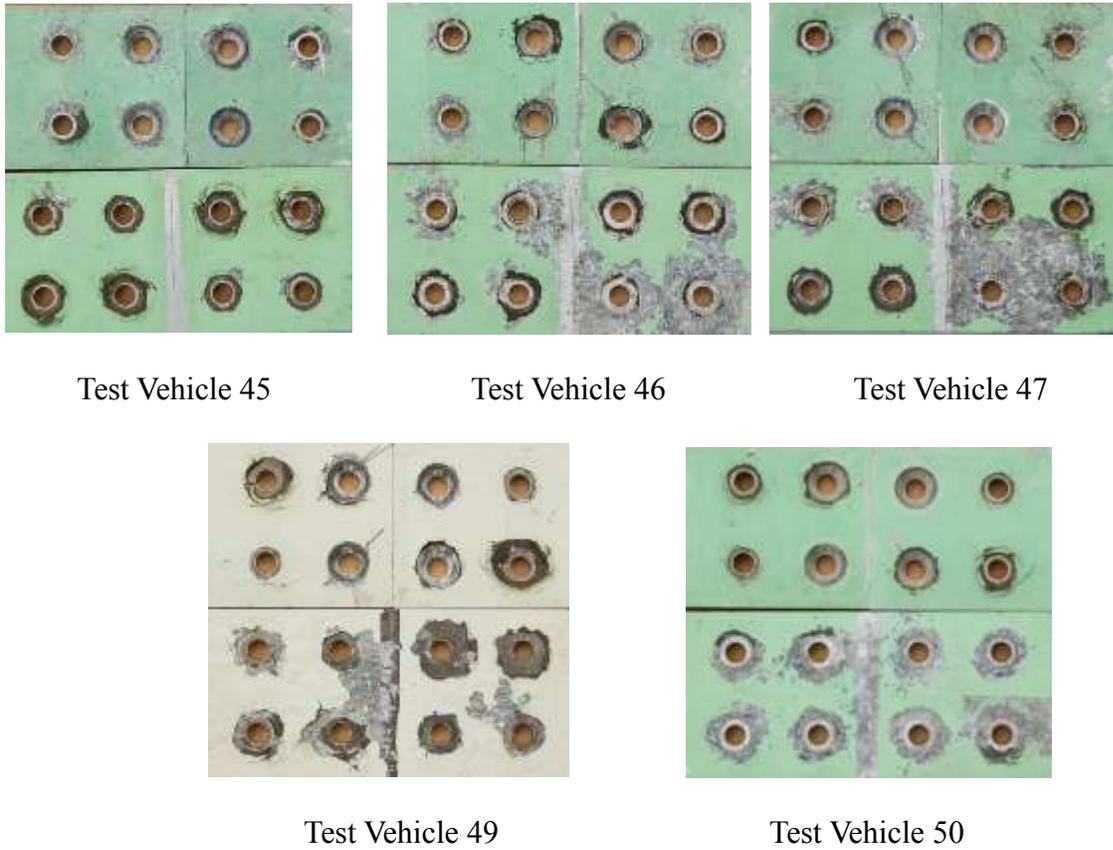
FIGURE A2. TEST VEHICLE EXTERIOR SURFACES POST DISASSEMBLY

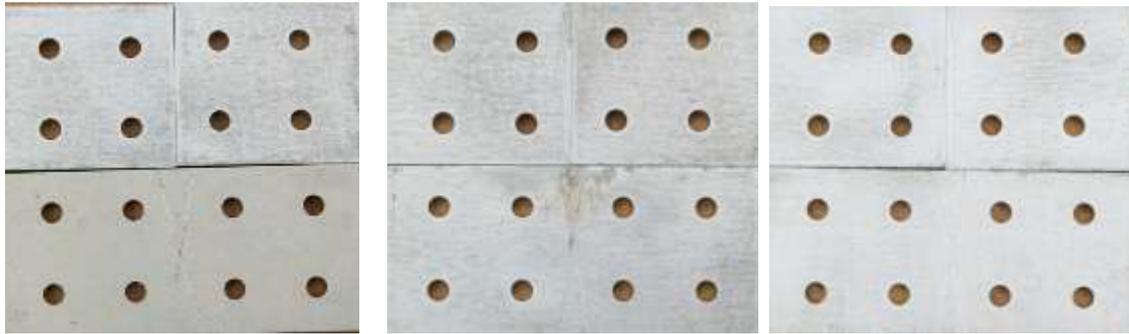
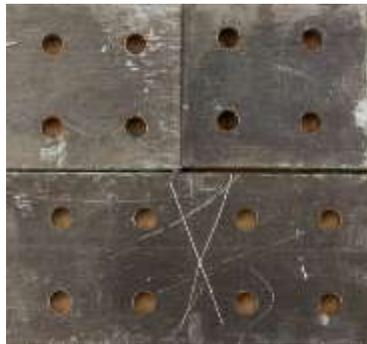
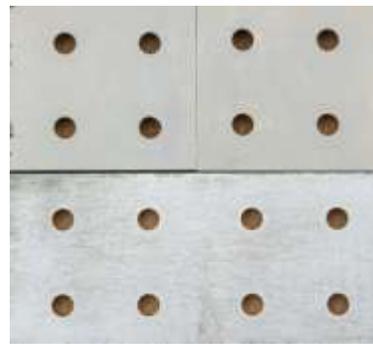
FIGURE A3. TEST VEHICLE FAYING SURFACES POST
DISASSEMBLY
