Hex-Chrome Free Sealant Project

Note: This is a revision of MPLR – 101436. This revision includes the test data and analysis of the Beachfront test vehicles after the Beachfront exposure near Daytona Beach.

MPLR – 101436A
June 10, 2014

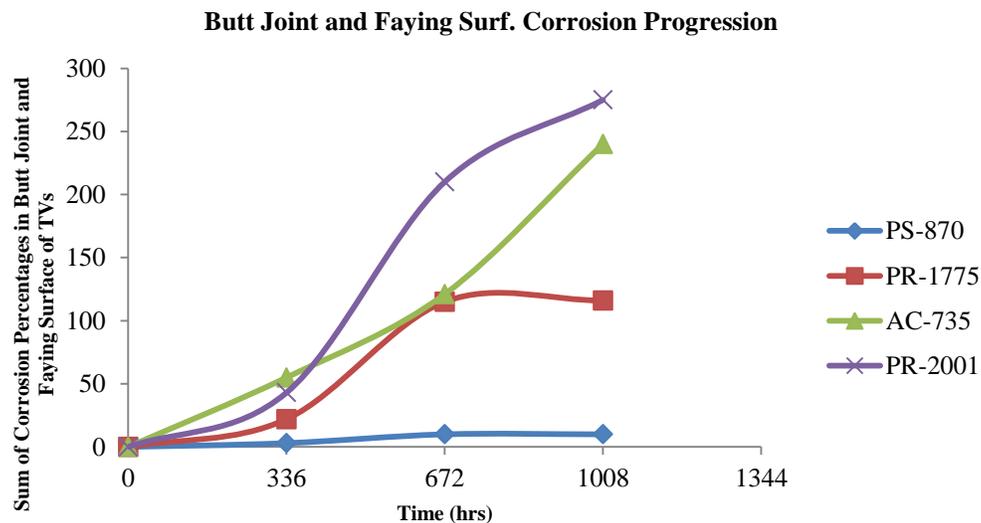
FIGURE 6.2.10 PROGRESSION OF CORROSION IN THE BUTT JOINTS AND FAYING SURFACE

Corrosion Progression in Butt Joints and Faying Surfaces				
Time (hrs)	PS-870 / Iridite / HCF Primer / 7075-T6	PR-1775 / Metalast / HCF Primer / 7075-T6	AC-735 / Metalast / HCF Primer / 7075-T6	PR-2001 / Metalast / HCF Primer / 7075-T6
0	0	0	0	0
336	3	22	55	43
672	10	115	121	210
1008	10	116	240	275

Figure 6.2.10 provides a chart to track the progression of corrosion over time in the butt joints and faying surfaces of the interim test vehicles. It should be noted that the lines between the data points were inserted to make it easier to follow the data for each sealant and are not the result of a regression analysis.

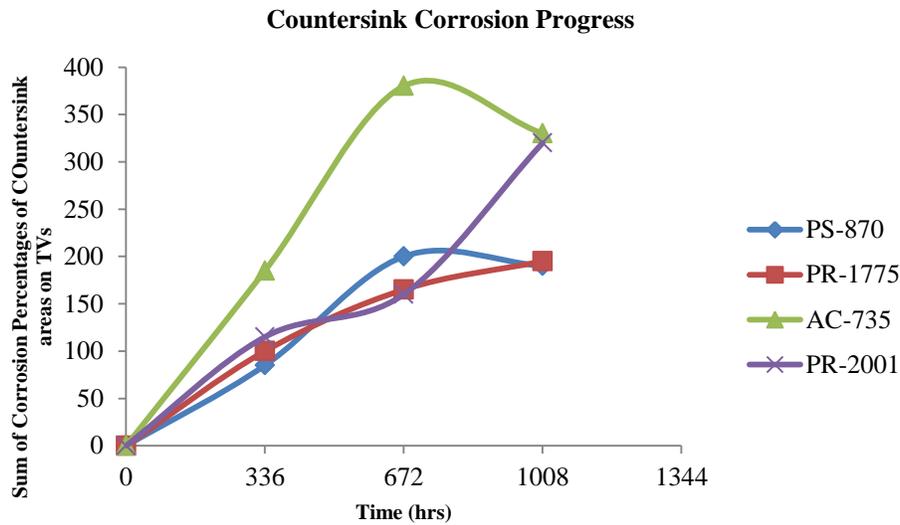
FIGURE 6.2.13 PROGRESSION OF CORROSION IN THE COUNTERSINK AREAS ONLY

Corrosion Progression in the Countersink Areas				
Time (hrs)	PS-870 / Iridite / HCF Primer / 7075-T6	PR-1775 / Metalast / HCF Primer / 7075-T6	AC-735 / Metalast / HCF Primer / 7075-T6	PR-2001 / Metalast / HCF Primer / 7075-T6
0	0	0	0	0
336	85	100	185	115
672	200	165	380	160
1008	190	195	330	320

Figure 6.2.13 provides a chart to track the progression of corrosion over time in the countersink areas of the interim test vehicles. It should be noted that the lines between the data points were inserted to make it easier to follow the data for each sealant and are not the result of a regression analysis.
