CIRCUITS ASSEMBLY

AUGUST 2007

Pb-free PTH Rework on a Thick, Heavy Assembly

A forced convection platform with a solder fountain showed a dramatic impact on copper dissolution.

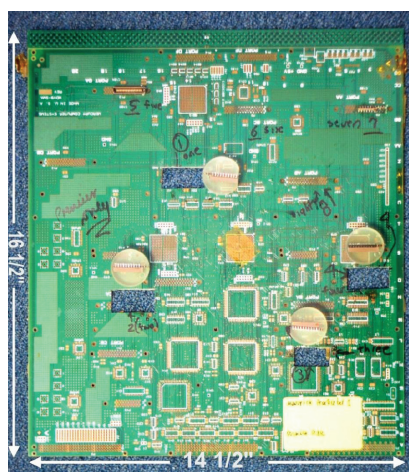
which permitted different techniques to be assessed at various board locations. The sites were sufficiently apart to minimize the thermal impact of rework from adjacent sites. The board was 14.5" by 16.5", 0.074" thick, and four of the 10 layers were power or ground. **Figures 1** and **2** show the practice board and respective component.

Figure 1. Practice board.

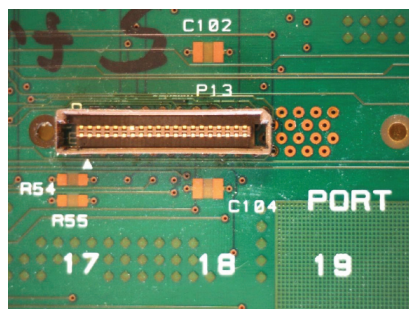
Figure 2. Close-up of the PTH component and rework site on the practice board (10 sites per board).

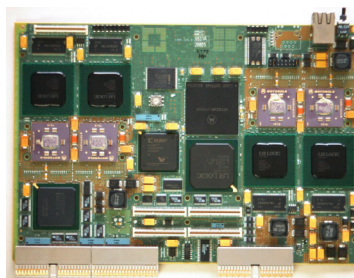
Figure 7. Maverick Card topside.

The Maverick Card is 0.084" thick, 16 layers with 7 ground/power planes. Compared to practice boards 1 and 2, it represents a significantly more difficult rework challenge in terms of thermal load. The component selected for rework on the Maverick Card was the 16-pin header at Location J6. The Maverick Card and the header at Location J6 appear in Figures 7 and 8.

The forced convection platform, in conjunction with the solder fountain, dramatically reduced the copper dissolution observed on the Maverick Card as compared with the rework done completely on the solder fountain. The former is the recommended rework process for thermally massive cards such as the Maverick Card.
