### Transition to Lead Free Electronics Assembly Case Study – Part II Product Reliability and Forced Rework

Robert Farrell, Scott Mazur, and Paul Bodmer Benchmark Electronics, Hudson NH Richard Russo, Mercury Computer Systems, Chelmsford MA Gregory Morose, Massachusetts Toxics Use Reduction Institute, Lowell MA

This paper is an extension of Part I and will include reliability results obtained from thermal cycling It will also include the results from the forced rework of BGAs and a through-hole component.

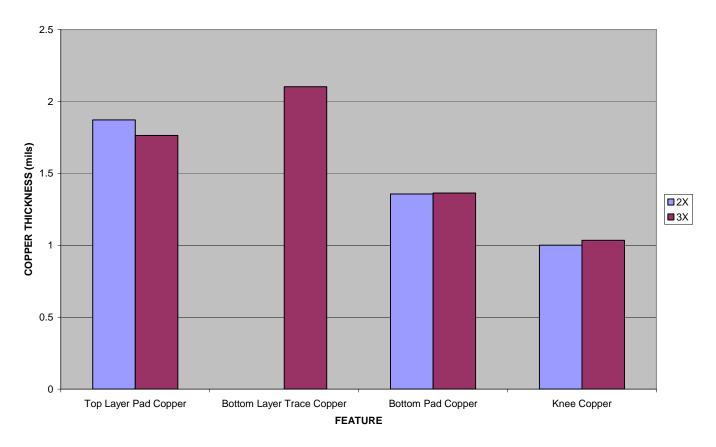
Figure 8 - Copper Thickness for the 2X and 3X Sites on Practice Board 2 (OSP):

The measured results were acceptable for the 2X and 3X reworks per IPC Class 3 criteria. The copper thickness at the knees did not go below 1 mil and the amount of copper dissolution on the 2X and 3 X rework were equivalent which was somewhat surprising. Cross sections of the 2X and 3X rework appear below in Figure 9. The 2X or 3X figure in the lower part of the image denotes the respective rework.

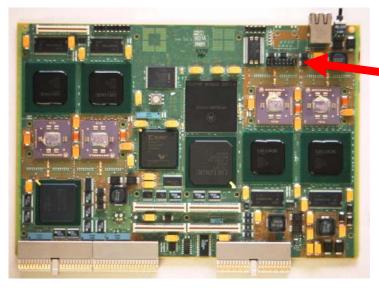
Figure 11: Close up of the Through Hole Header reworked at Location J6. The arrow references Location J6 on the board.

The Maverick Card is 84 mils thick, 16 layers with 7 ground/power planes. Compared to the Practice Boards, it represents a significantly more difficult rework challenge in terms of thermal load. The component selected for rework on the Maverick card was the 16 pin header at Location J6. The Maverick Card and the Header at Location J6 appear in Figures 10 and 11.

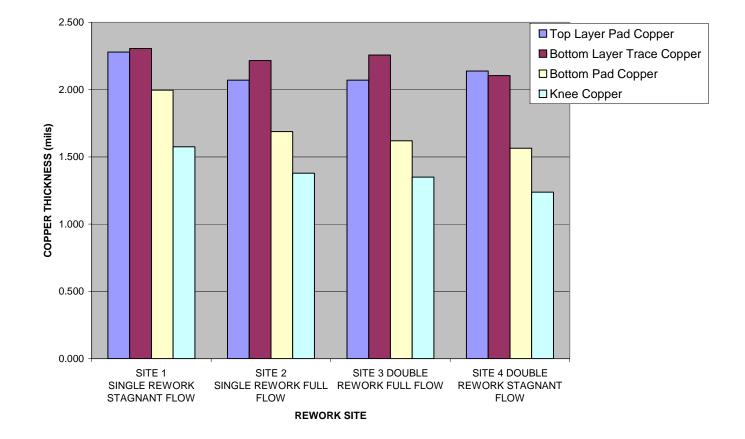
# Practice Board #1 Results (Copper Dissolution)

- All four sites were considered acceptable. There were no excessively thin or fractured knees, nor was there any significant via wall thinning near the surface. Copper thickness was above the IPC Class 3 minimum of .001" (1 mil).
- Copper dissolution increased for the double rework as compared with the single rework which was expected but the increase was smaller than anticipated.
- The difference in copper dissolution between the stagnant and full flow was not significant.
- By the end of the double rework process, the bottom side pads have lost approximately one-quarter of their original copper, regardless of method used.

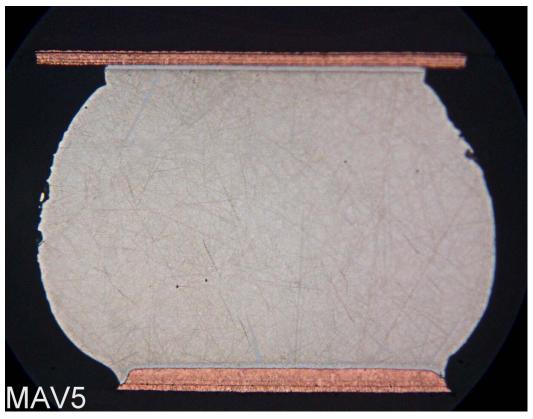
# Representative Results after Double BGA Rework on an OSP Maverick Card

The card was tested electrically before and after the double rework and passed both tests. The cross sections in Figures 19 and 20 illustrate the results which are acceptable per IPC Class 3 criteria. There is good wetting, minimal voiding, good symmetry, and minimal copper dissolution on the pad. Moreover, no damage was observed to the PCB. However, the press pin connectors on the edge of the board were thermally degraded and had to be replaced after the double rework in order to complete the electrical testing. The press pin components were not rated to 260 C.
