# S.E. Shires Company

## *Toxics Use Reduction Case Study*

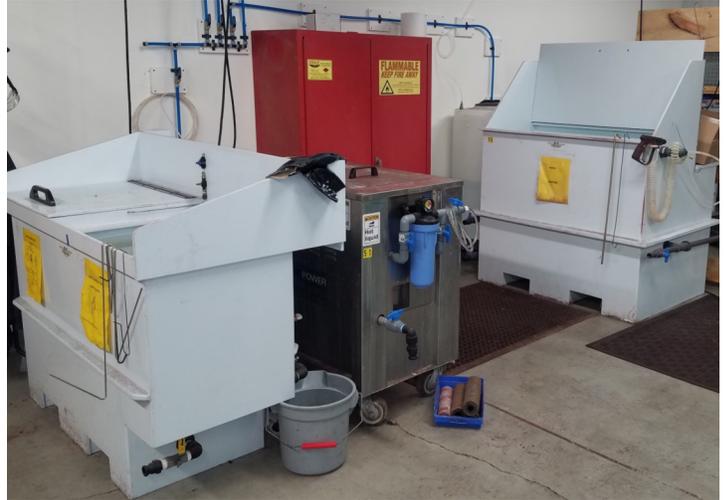
Right to Left: Benzyl Alcohol Lacquer Strip and Rinse, Ultrasonic Aqueous System, Rinse Tank

Previously, workers used methylene chloride to strip for re-lacquering any instruments or parts not meeting quality control standards. This part of the operation is not regularly used; however, the company was concerned about worker safety and continued to look for safer alternatives. In 2017, the facility was able to successfully switch to a benzyl alcohol lacquer stripper and eliminate the annual use of 300 pounds methylene chloride.

S.E. Shires had their grand opening in Holliston, May 2018. While planning for the relocation, the company evaluated opportunities to upgrade equipment and make improvements to environmental and worker safety in the new facility. Besides the new aqueous cleaning and lacquer stripping systems, S.E. Shires has also installed a larger spray booth built to meet current environmental and safety standards. James Monaghan, General Manager, put significant thought into how the new facility should be organized so that production flows more efficiently. In the near future, as a result of business brought in by Eastman Music Company, the Holliston facility is preparing for a 50% increase in production with new process equipment using less toxic chemistries. Operations are now free of any chlorinated, brominated, or fluorinated solvents.
