Morgan Advanced Materials Triumphs over TCE

Morgan Advanced Materials

SUMMARY

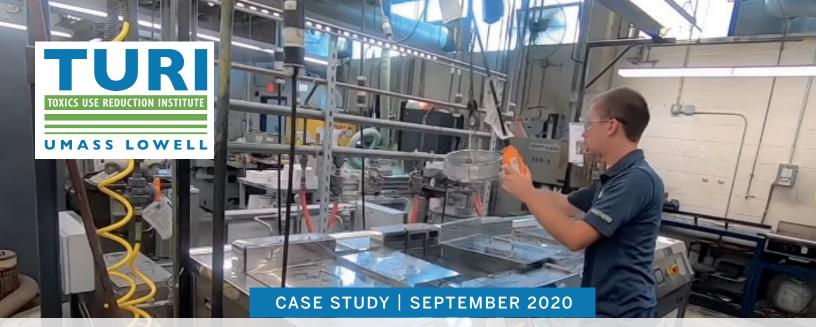
Clean parts after pink wax removed

Dirty parts with brown wax residue

Clean parts after brown wax removed

A final test was completed by the TURI lab comparing a powder detergent and a liquid detergent on Morgan's brown wax-contaminated parts adhered to a metal plate (see image on p. 1). Due to limited parts available at the lab, only two cleaners were tested at the two different temperatures.
