Lean Manufacturing Implementation at Food & Beverage Processing and Manufacturing Facilities

December 2021

This report was prepared by Joy Onasch from the Toxics Use Reduction Institute at UMass Lowell. The content is based on project work completed by the representatives of the companies identified who took part in the Lean manufacturing course. Both the course and the writing of this report was supported by a grant from a Region 1 EPA Healthy Communities Grant (Lean Manufacturing and Pollution Prevention in the Food and Beverage Sector for Healthy Communities; Grant ID Number: HC - 00A00550 – 0). The participation of the companies and the support of EPA is greatly appreciated.

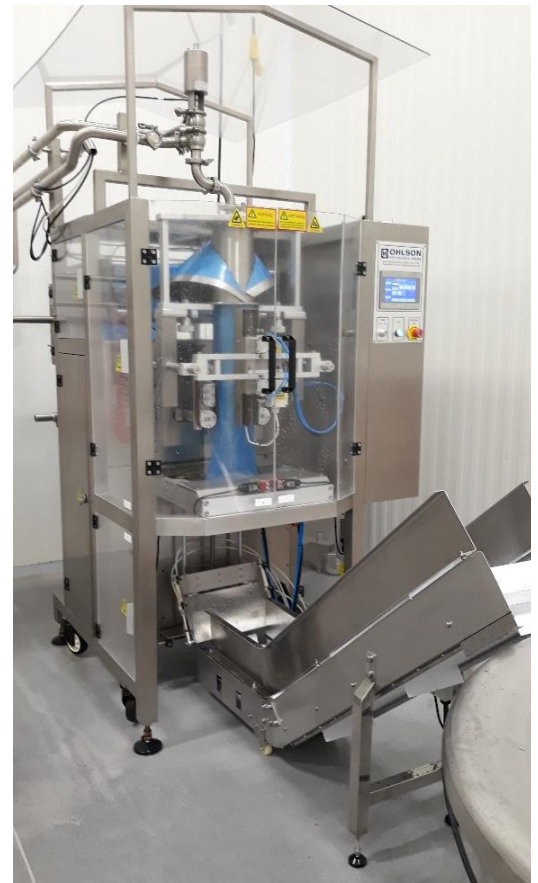
Cedar's new bagging machine

The in-house Engineering Department oversaw the installation of the new bagging machine using the thin film. The bag machine was installed in March 2021 and Cedar's ran a pilot study to fill some bags with toppings to run quality-control shelf-life studies. This step was completed with satisfactory results. The topping bagger was up and running in July of 2021.

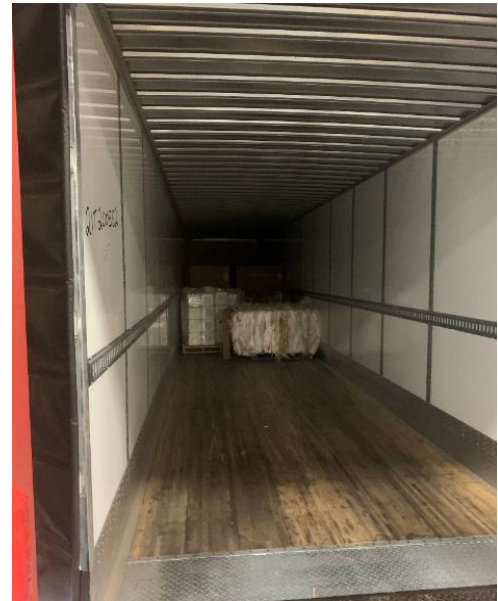
Nearly empty tractor trailer

The batching process generates an average of 55 drums per week and fills a tractor trailer load once per month (though this varies seasonally). Coca-Cola also averages 200 pails or approximately 4 pallets worth of small containers per week. These 4 pallets take up approximately 40% of the trailer space for recycling. Coca-Cola ships the small container trailer loads, which are only partially filled, 2 to 3 times per week.

Because the containers are empty, Coca-Cola is essentially shipping large volumes of air while attempting to recycle the drums and small containers used in the batching process. In addition, per internal requirements, employees must deface each container, which takes time away from production.

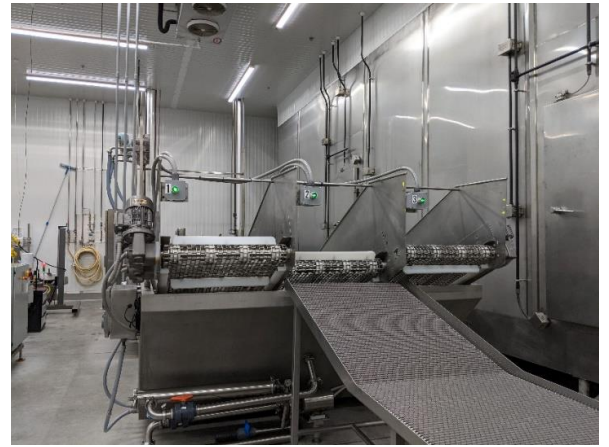
Conveyor off of three lane chiller

The quality control and maintenance teams at Plenus have implemented the Lean tools to help reduce water being wasted at the facility. The quality control team first initiated the idea of a skirting system for the conveyor belt coming out of the chiller to keep the bags from being snagged. However, the maintenance team did not think the skirting system would work. They then proposed the idea of lowering the angle on the conveyor belt so that bags would more easily drop off the conveyor and not get snagged underneath.

The change in the chiller conveyor belt angle was immediately implemented and resulted in an 80-90% reduction in ripped bags.
